**THE THIRTIETH LEGISLATURE
APPLICATION FOR GRANTS
CHAPTER 42F, HAWAII REVISED STATUTES**

HALE PUNA

Hale Puna is requesting funding to conduct emergency repairs on a historic property in Waimea Town, Kauai, and launch a \$2 million capital campaign to restore this 190 year-old site representing a vital part of Kauai's history.

HISTORIC STRUCTURES REPORT
FOR
THE GULICK-ROWELL HOUSE
Waimea, Kauai, Hawaii

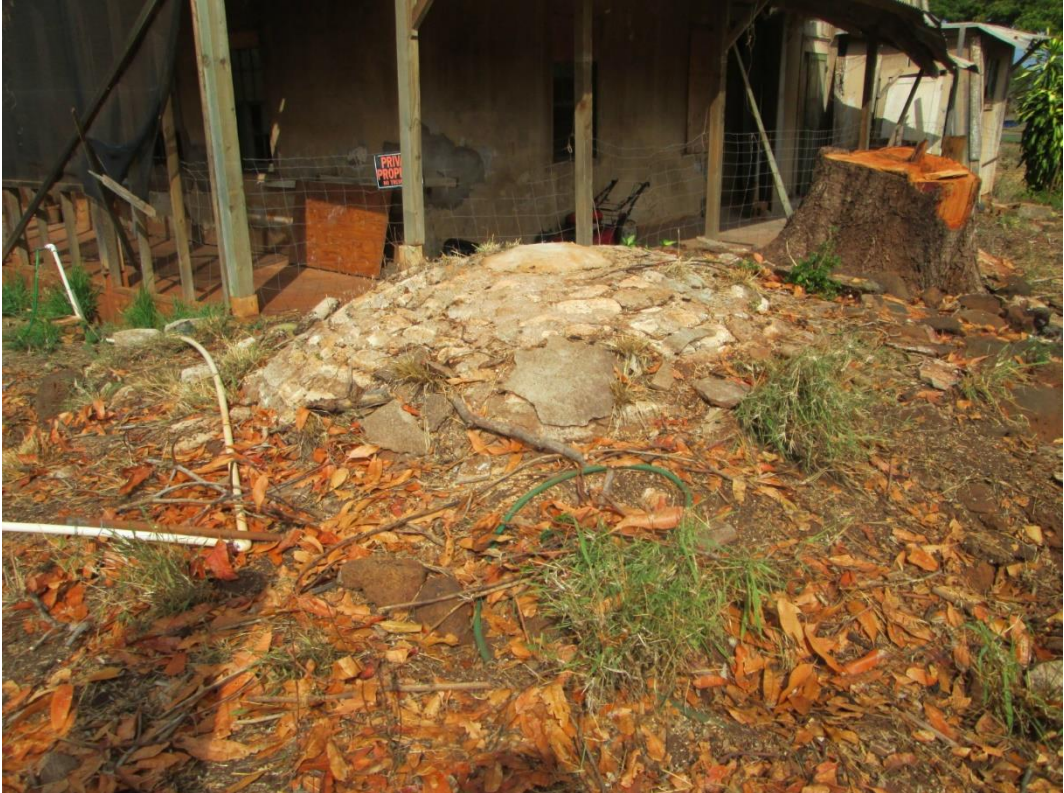
Figure 9: Cistern. Photo taken in 2015, prior to collapse of north shed roof structure.

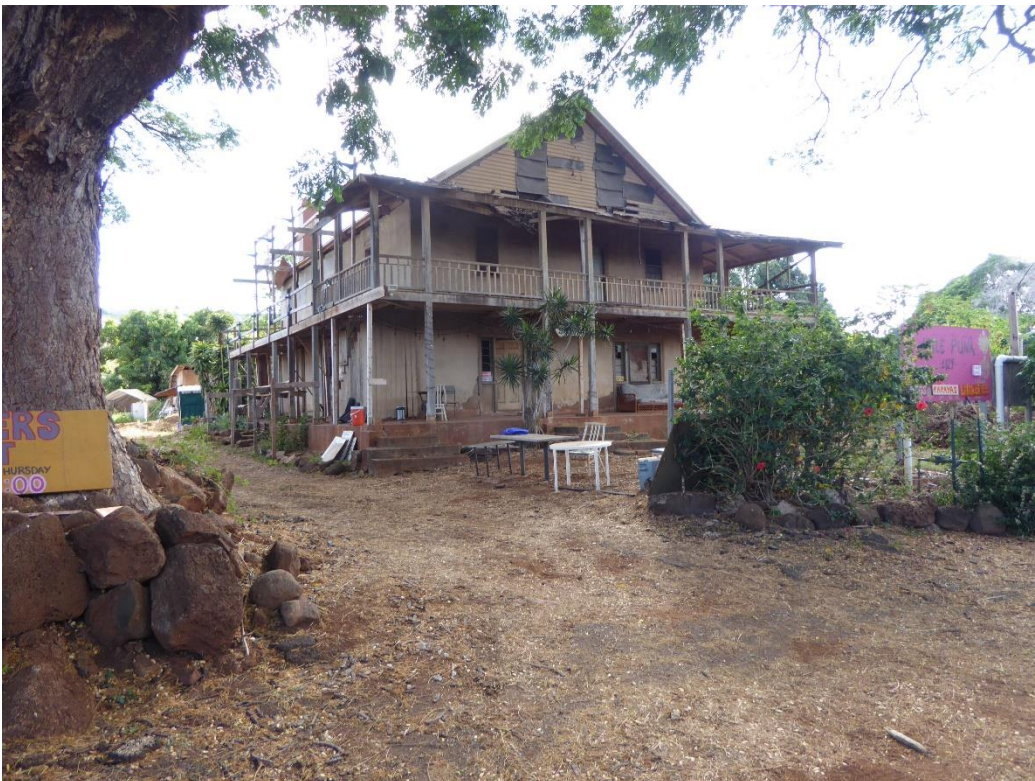
The roofing over the decks was not replaced in 2018, and as a result this has accelerated the deterioration of those lower sloped portions of the structure since there is no continuity between the upper and deck roofs. The single story shed roof over the north deck is now gone (it still existed in 2015) and the roof over the west deck has been removed. The roof over the other portions of the deck still exist, but in deteriorated condition.

Figure 11: Photo taken in 2019. Note gable roof eave and missing roof over west deck.

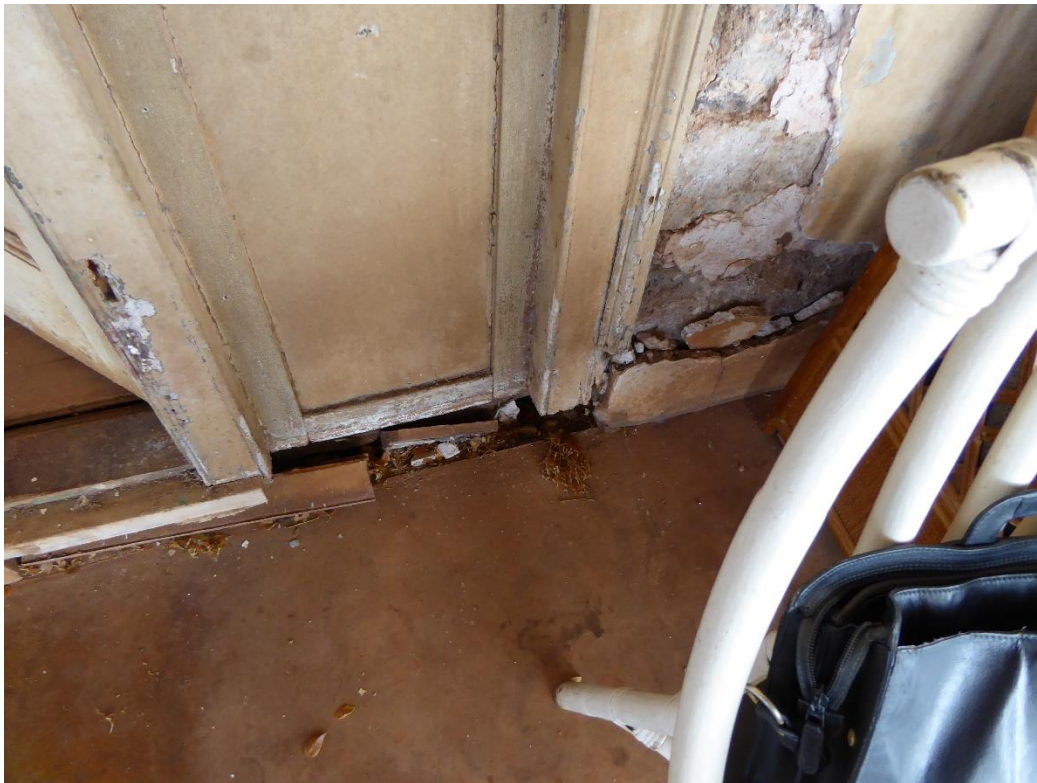
The base of the walls next to the concrete deck has been repaired with newer cement plaster in most areas. Although this may have been partially attributable to potted plants

being watered next to the walls it is equally likely that the previous damage was due to some form of rising damp exacerbated by filling and pouring concrete against those walls. Other areas have also been plastered with cement plaster (Figure 13).

Figure 13: Plaster adjacent to south door has failed. Note cement plaster remains at base.

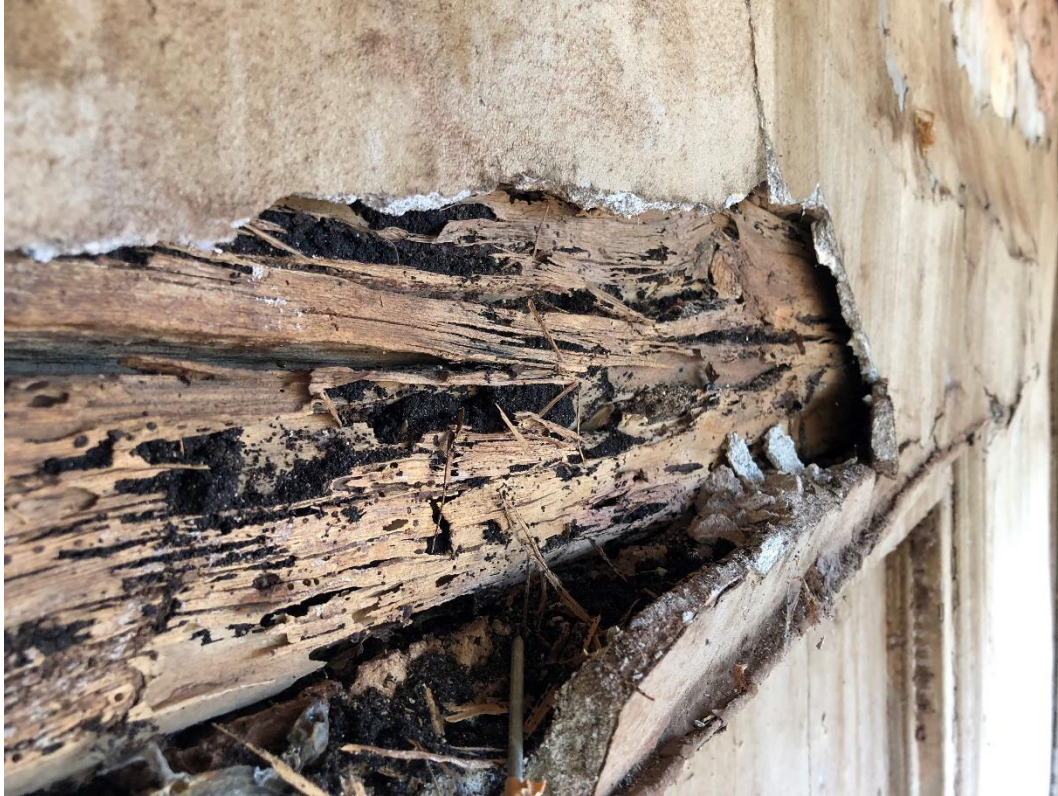
Lintels over openings in the walls are from hand-hewn timber. The plaster over the beams is cracking in some locations and above window 10 the removal of the plaster revealed termite damage to the wood lintel. The termite damage appears significant but superficial and the lintel may be left in place. It is noted in this location that the lintel is long enough to span the window and the adjacent recess.

Figure 14: Lintel over window 10

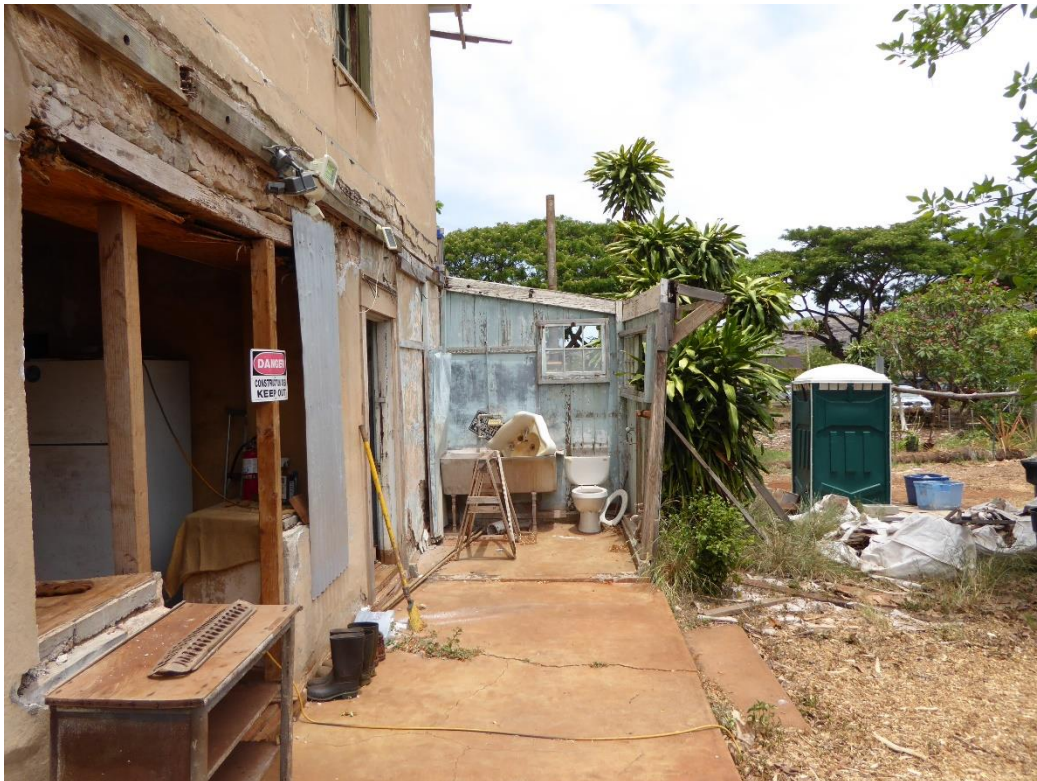
A single long lintel was used to span the opening to the Dining Room on the north side (Figure 15). The lintel appears to be in good condition but it is now bending and is taking too much load from the masonry wall above. There used to be a door with windows on either side of it in this location and the jambs between the door and windows likely provided additional support for that lintel. With them gone the lintel is left to take more weight than it should³.

Figure 15: Lintel over opening at left on north side. Remains of the washroom beyond.

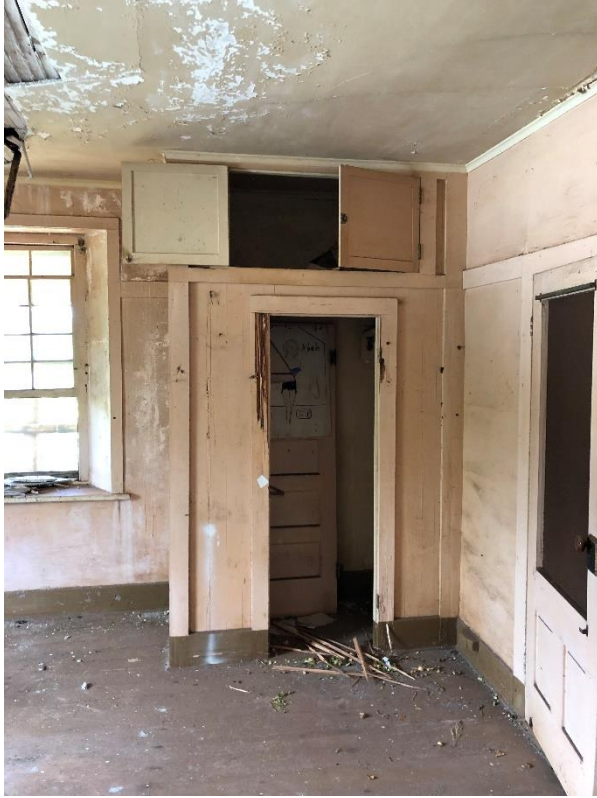
At the second floor most of the interior walls are plastered. These walls are noticeably cracking but seem relatively solid. Limited destructive testing is justified to determine the cause of the cracking. Also at the second floor, several closets were constructed out of 3/4" thick tongue and groove material. The closet in Bedroom 4 has extensive termite damage and will largely need to be reconstructed (Figure 18).

Figure 18: Closet in Bedroom 4.

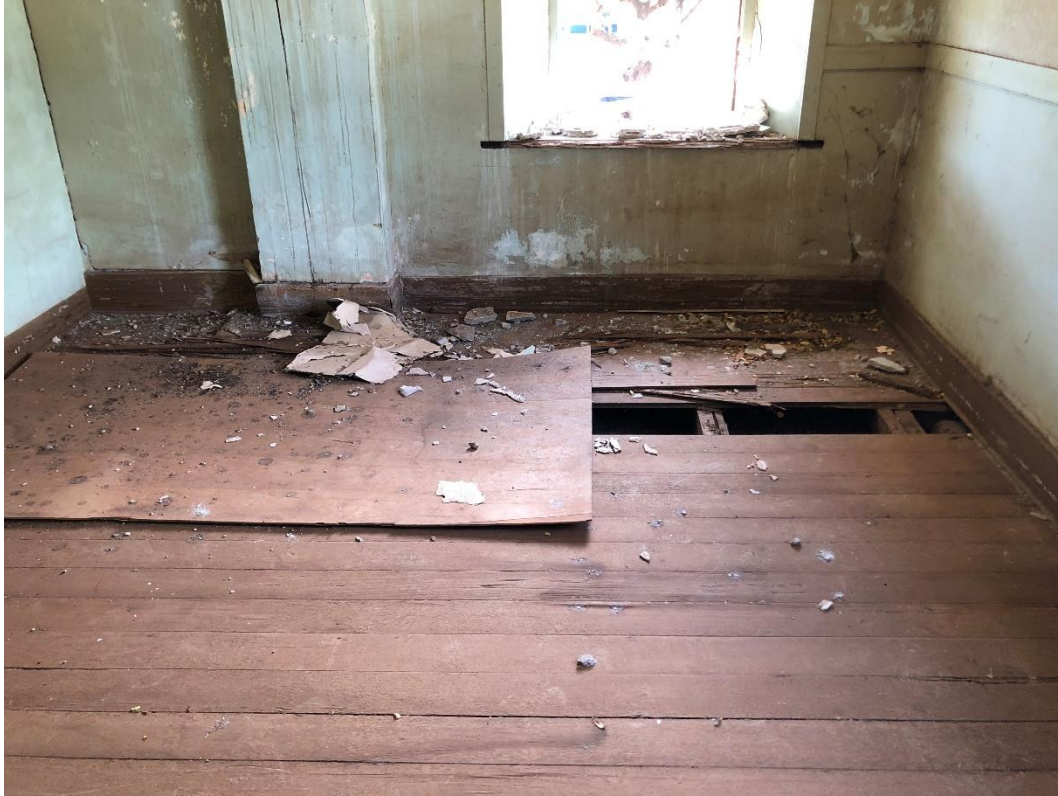
Figure 22: Damaged floor in bedroom 3. Note the wall thickness change at the chimney

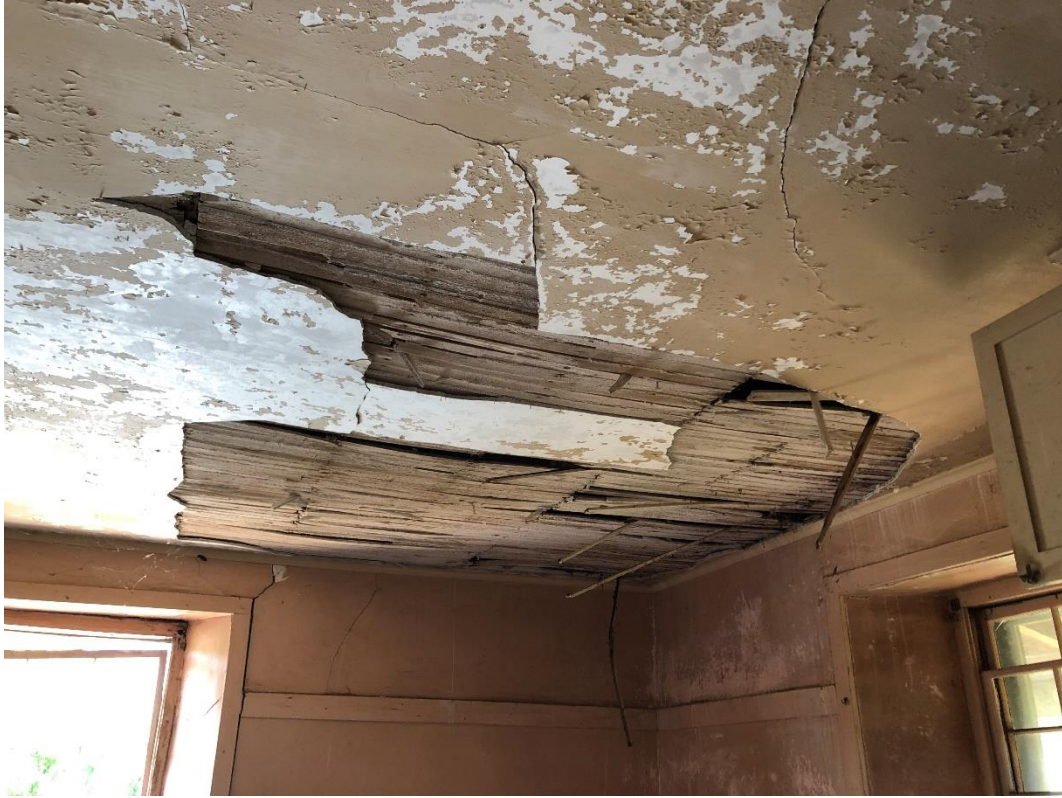
Ceilings of the second floor interior are all plaster on wood lath, except that the ceiling in the bathroom is 1/4" gypsum board applied directly to the floor framing above. Portions of all the second floor ceilings have collapsed in every room (Figure 24). In most cases the lath appears to be ok, but there is some deterioration of the lath in Bedroom 4. Figure

Figure 24: Typical ceiling damage at second floor.

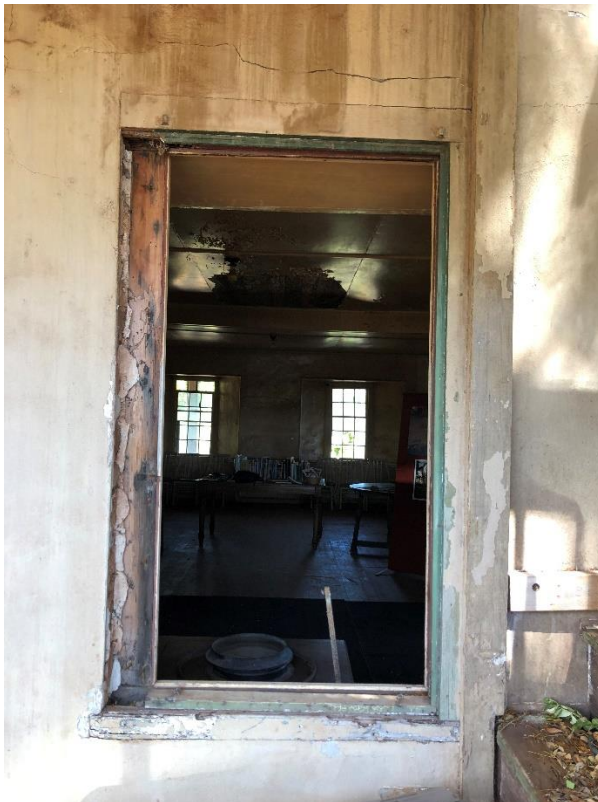
Window	Description	Recommended work
First Floor		
1.	Sash is missing (Figure 27). The sill nosing is badly termite eaten and north jamb is gone. The interior casing on the north side is intact and a cut nail is evident, used to attach the casing to the former jamb.	<ul style="list-style-type: none"> • Replace sash with 6 over 9 light sash to match window 3. • Provide new spring sash holder to match older style.
2.	6 over 9 light sash (Figure 28). Sash in good condition. Three panes of glass are missing, each being about 8” wide x 10” tall. Sill and apron termite eaten. Sill and apron are embedded in the exterior plaster of the wall.	<ul style="list-style-type: none"> • Replace three missing panes of glass with salvaged glass or new light restoration glass. • Reglaze existing sash. • Epoxy fill the termite eaten portions of the sill. • Paint • Refurbish existing spring holder for reuse.

Figure 27: Location of window 1.

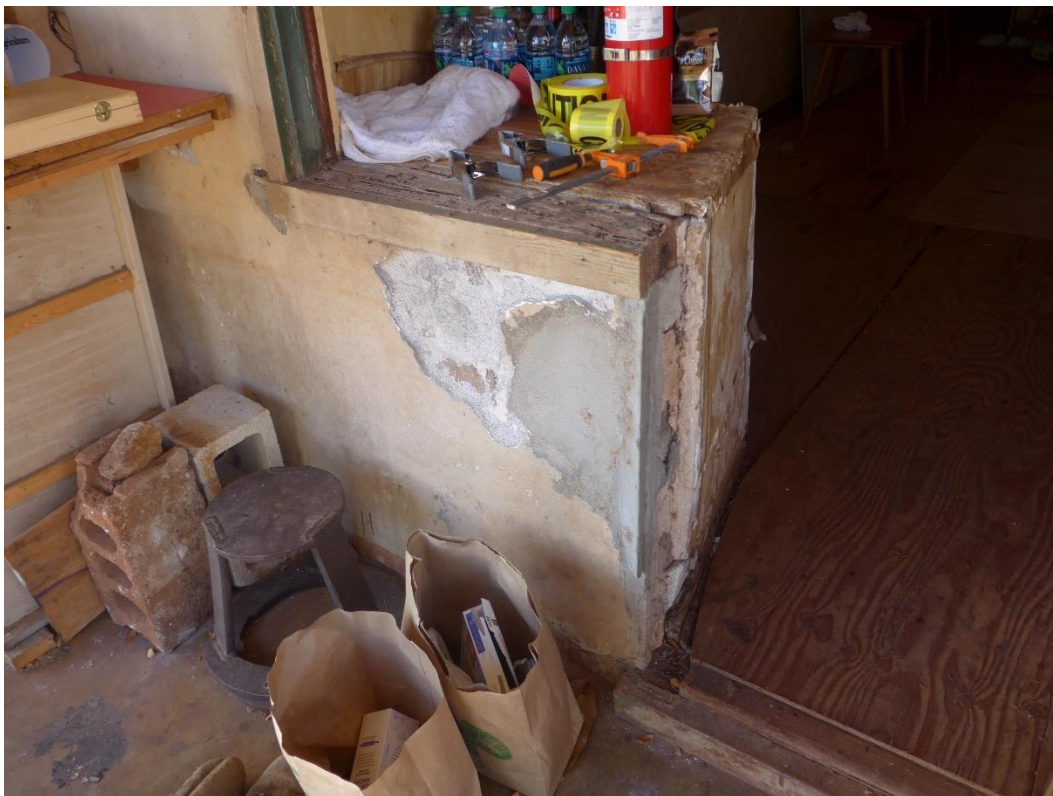
7.	Window is gone.	No historic photos have been found that show this window, or window 8. The sill and portion of the jamb that remained in 2015 show that the window was a double hung window (Figure 29). The jamb and sill are now gone. Window should be replaced with new 6 over 6 light double hung window.

Figure 29: Photo taken in 2015 showing the jamb and sill of the previous window 7.

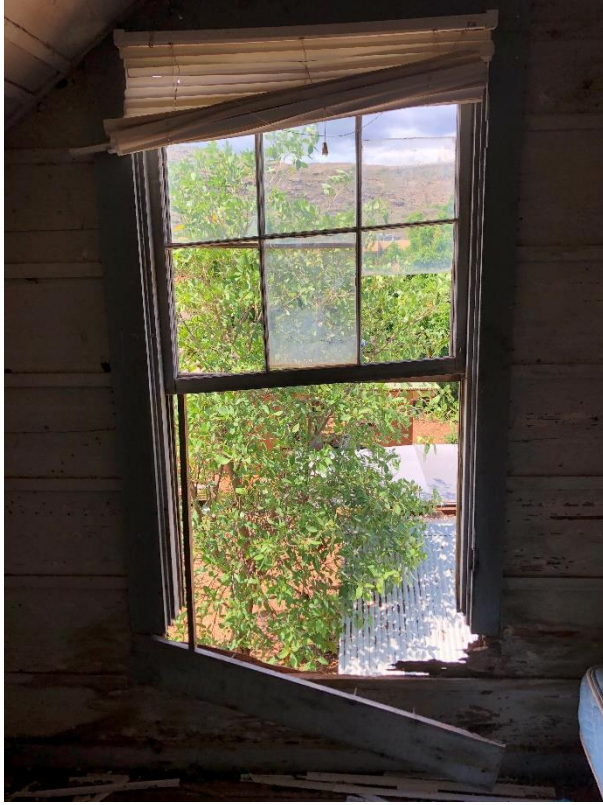
Figure 30: Window 31 sash is close to collapse.

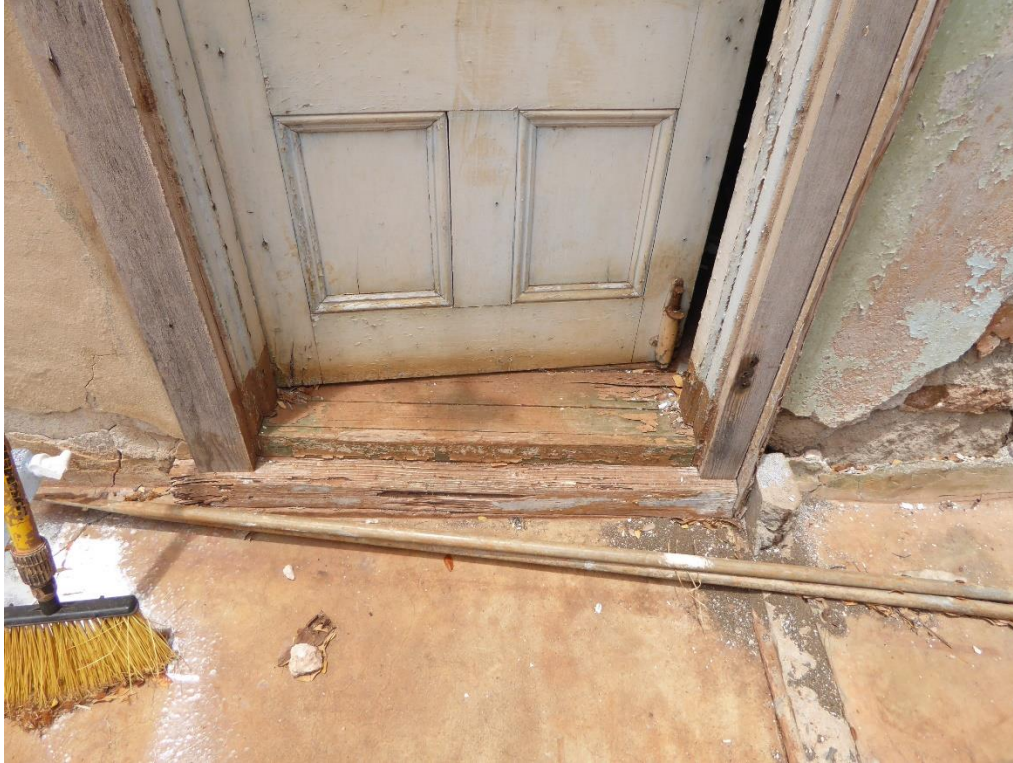
Figure 34: Sill of Door "E". Note remnant of concrete curb and deteriorated plaster which exposed coralline wall construction.

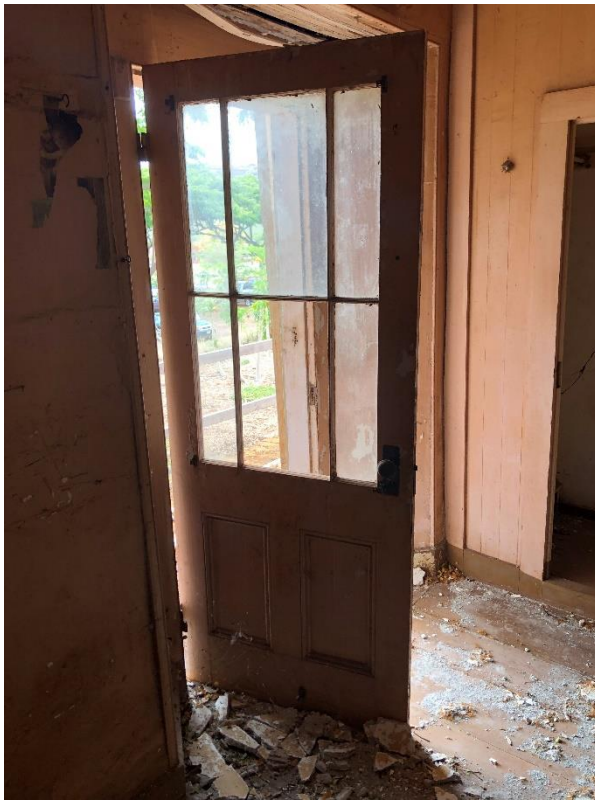
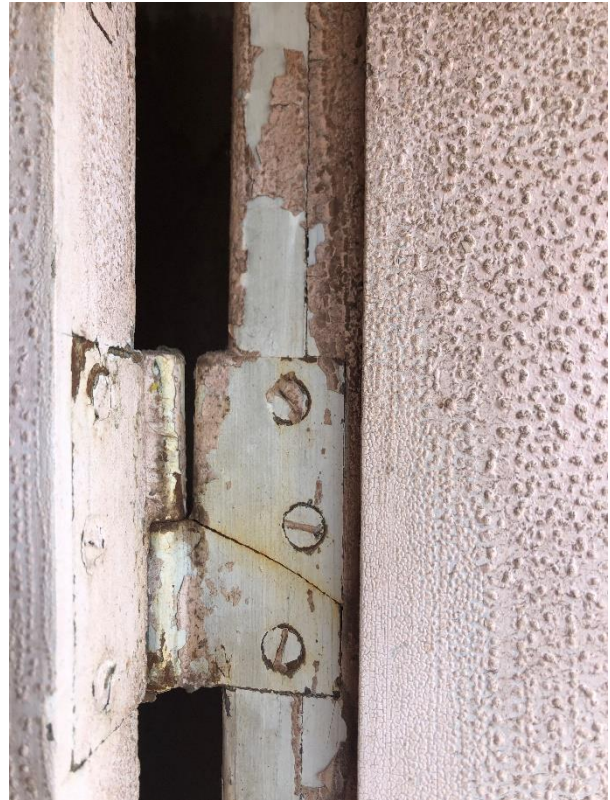
Figure 39: Door U shown on the left. Cracked upper hinge at Door U.

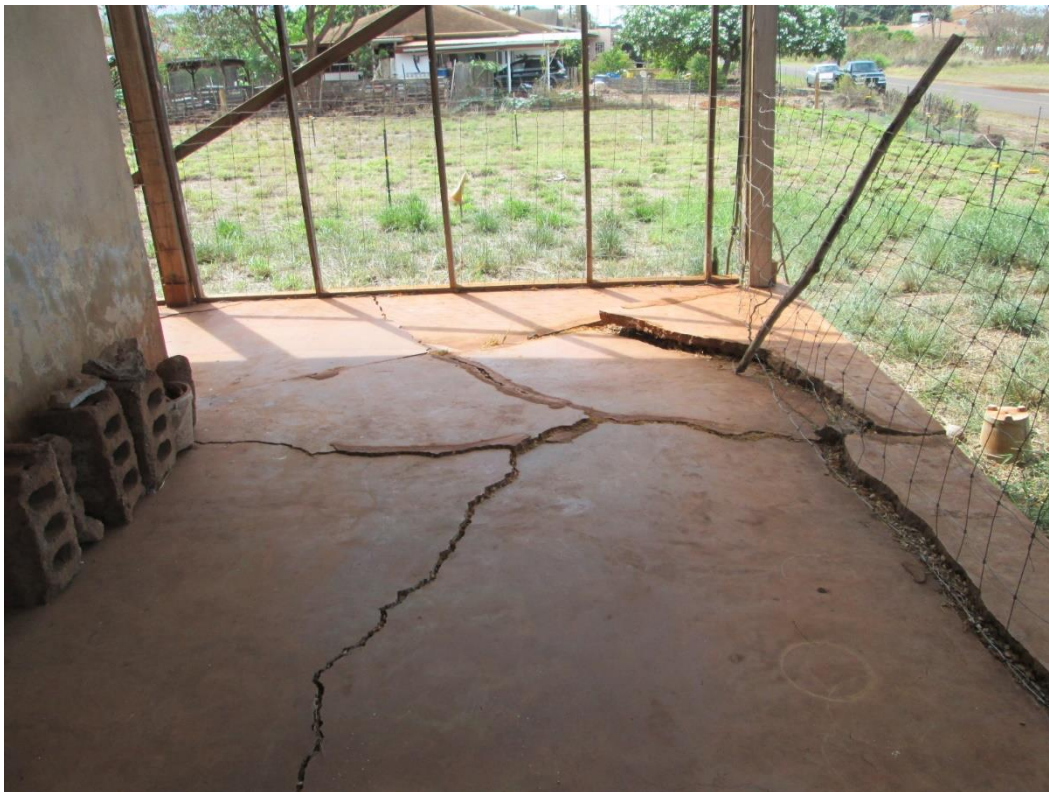
Figure 49: Damage to deck at southeast corner. Photo taken in 2015.

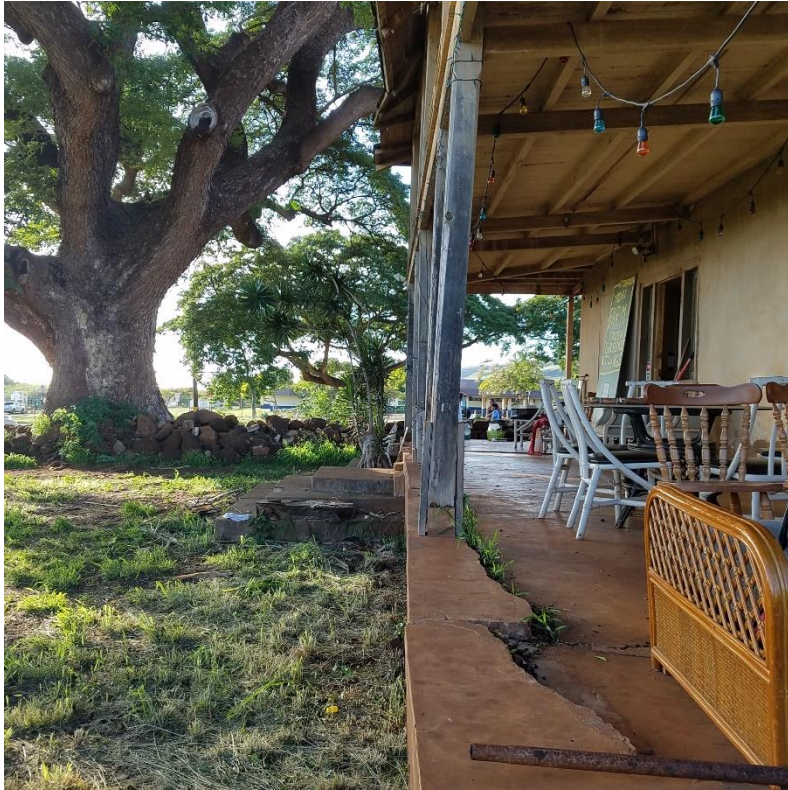
Figure 50: Retaining wall separating from deck and leaning south. (Taken 2015)

- Demolish Existing 2nd Floor Deck, Framing & Railing
- Remove & Salvage Existing 2nd Floor Deck & Framing
- Demolish Damaged Concrete Deck Floor Slab and existing retaining wall
- Install New Retaining Wall 2' HT, Reuse Existing Footing
- Install New Concrete Deck Slab on Grade
- Finish Concrete Deck to Match Existing
- Finish Retaining Wall to Match Existing

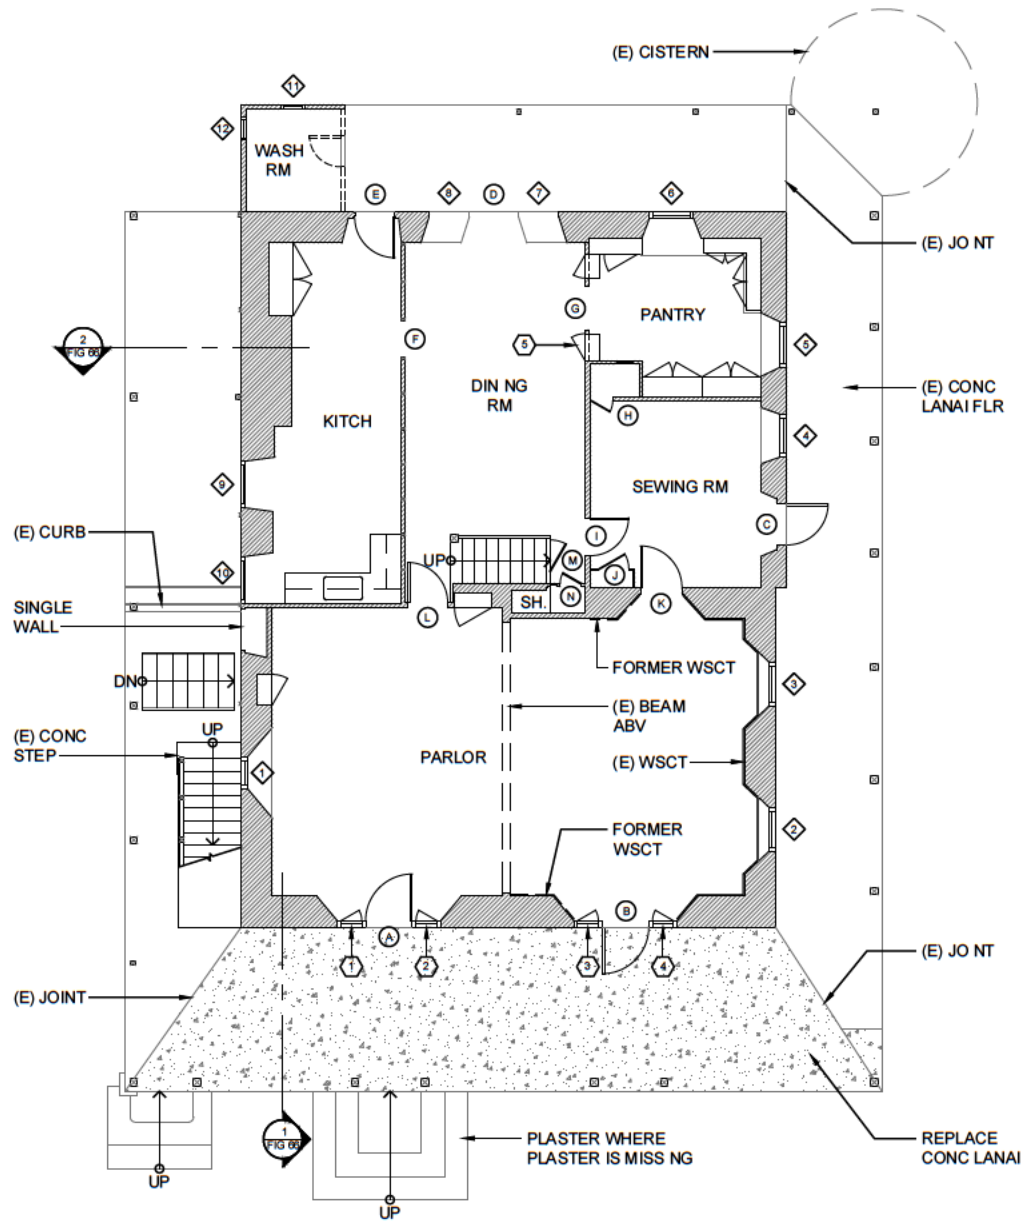
- ① MISSING ONE MUNTIN SILL AT BASE IS BAD. NO GLASS.
- ② NO GLASS. MISSING SILL AT BOTTOM.
- ③ NO GLASS. REPLACE BOTTOM RAIL AT BOTTOM PANEL.
- ④ NO GLASS. REPAIR MIDDLE MULLION. BOTTOM PANEL IS MISSING, REPLACE ENTIRE PANEL. BOTTOM 12 INCHES OF RIGHT JAMB IS BAD. PATCH IN NEW JAMB.
- ⑤ 1'-4 1/4" WIDE X 3'-11 1/2" TALL WITH 5 LITES. GLASS KNOB.
