Grant-In-Aid CIP Application for Grants & Subsidies Fiscal Year 2014

BIG ISLAND HEAD START PROGRAM

STRUCTURAL ASSESSMENT FOR:
THE Child Development Center
2133 Waianuenue, Hilo, Hawaii

Hilo Head Start Structural Assessment

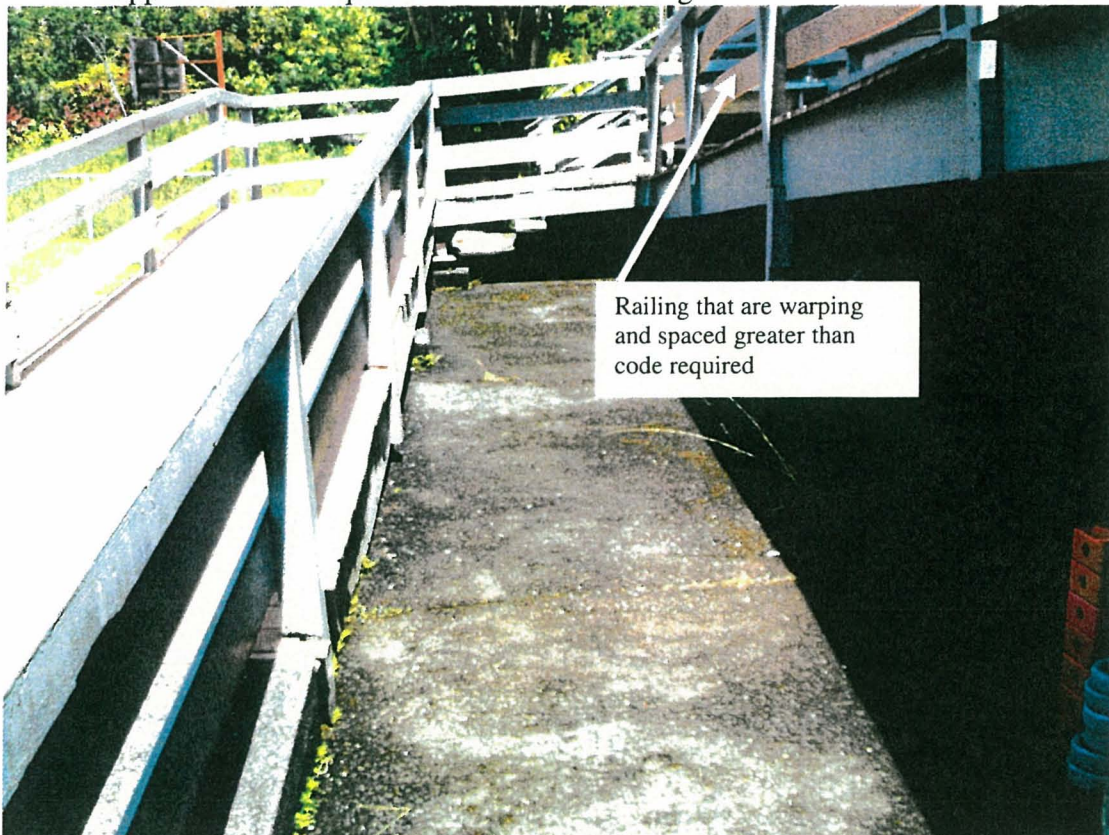
Figure 1 - West Ramp looking North

- 1.1 Currently the area of the greatest concern is the railings around the building. Code requires that a sphere 4" or greater cannot pass through any of the railings. The railings are wider than this gap, which means that a child could get his head stuck in the railings. The railings to the ramp are also warped and built out of a manufactured lumber that is not suitable for railing applications and will not support the code required lateral load for railings.

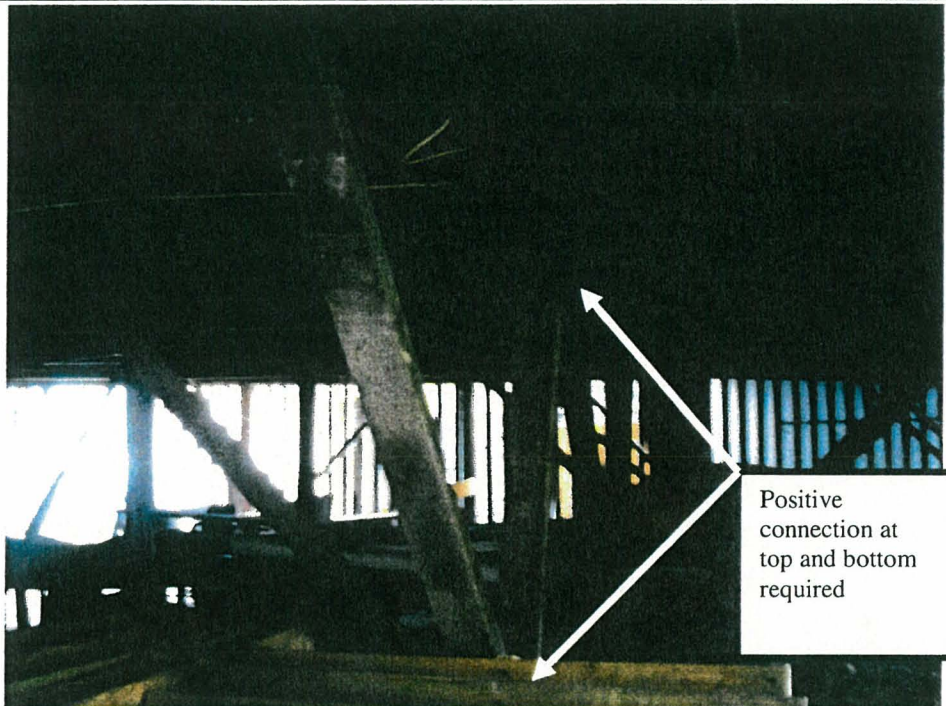
Figure 2 - Photo of bottom area of North Building

- 2.4 The 4x6 beams holding the first floor joists are supported by existing 4x4 columns. These columns will need to be attached to the beams with flat a LTP4 or APC44. This will create a positive connection between the post and the beam. If the column is set on existing concrete there will need to be an A311 angle attached to the concrete with a 1/2" threaded rod epoxied 3" into the concrete. The A311 will need to be lag bolted to the post with a 1/2" lag bolt embedded 3" into the wood. If the 4x4 is set on lava rock, a new pre-cast concrete pad 16" square with an embedded base will need to be set on compacted soil fill under these posts.

- 6.5 Attach Simpson LTP4 or APC44's to 4x6 beams under first floor joists and existing 4x4 columns. Install A311 angles to concrete base with a 1/2" threaded rod epoxied 3" deep into concrete. The rod is to be stainless steel or the rods are to be cold galvanized on site after placement to cover any exposed steel. A311 to be lag bolted to posts with 1/2" lag bolt embedded 3" into the wood. Where 4x4 is set on lava rock replace with new pre-cast concrete pad 16" square with base embedded onto compacted soil. Section 2.4 Appendix A.

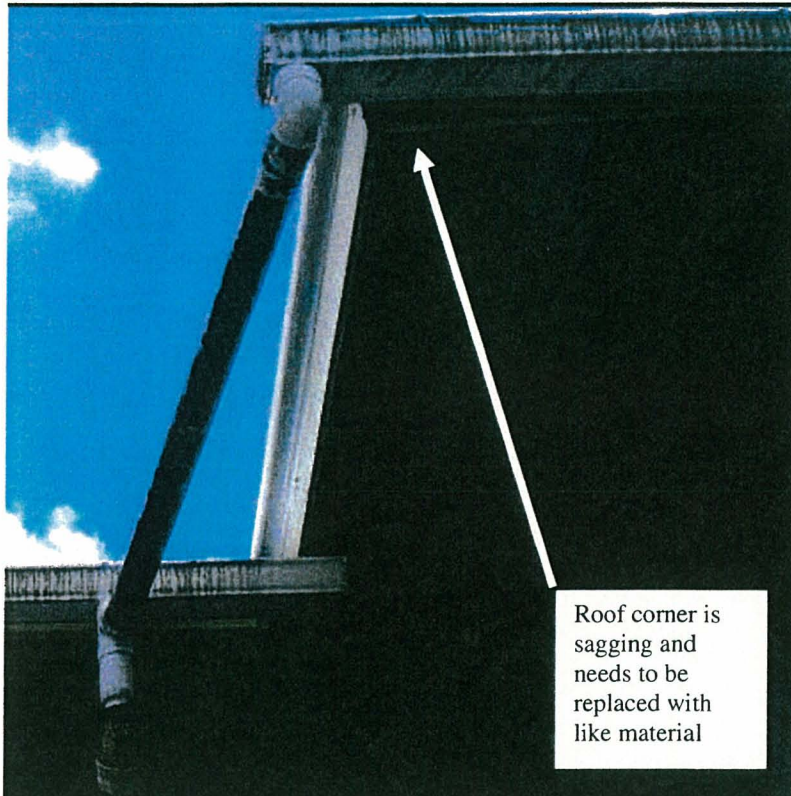
Figure 3 - Roof corner at Kitchen

- 2.9 The family reading room on the northwest corner is also slanted. It is okay to leave this room as is.
- 2.10 The corner eave at the northwest side of the kitchen is showing signs of rot and sagging. A new corner needs to be re-framed using the same original materials.

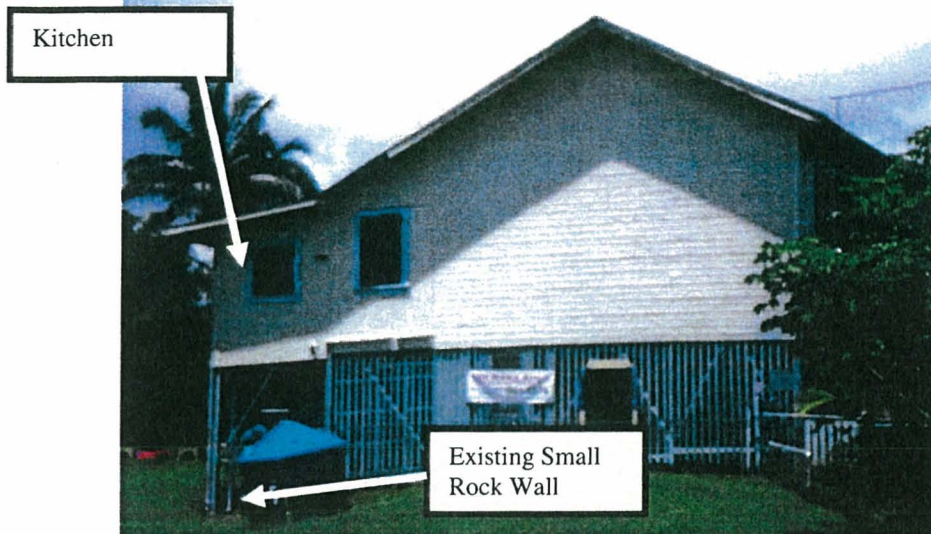
Figure 4 – Looking North

- 2.15 The South building rafters over the eaves are insufficient for the spans. A new 2x8 ledger above the doors will need to be attached to the building with 3/8" lags spaced at 16" on center. A 2x4 diagonal brace will span from the ledger to the rafters and the skip sheathing. This member will cut down the span of the rafters and skip sheathing to an acceptable level. The angle can bear on top of top of the ledger and be attached to the ledger and rafter with an H2.5 clip.
- 2.16 Under the kitchen the grade should be re-worked such that the existing rock retaining wall can be removed or redone to provide a safer passage for children.

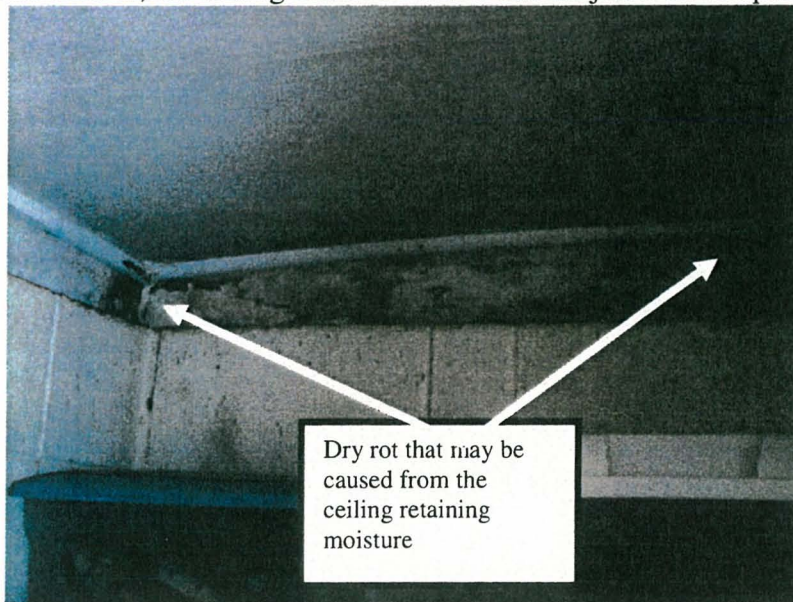
Figure 5 - Ceiling in Toy room

- 2.17 The several of the ceilings on the southern building are currently covered with a gypsum board ceiling. This ceiling is retaining some of the moisture in the floor space and may be causing some dry rot or nesting areas in the floor space. It is best to remove this ceiling covering to let the wood breath naturally. If a finished space is desired, the ceiling can be removed and the joists can be painted.
