Island-wide Outage and Restoration

December 26 and 27, 2008

January 14, 2009 Legislative Briefing

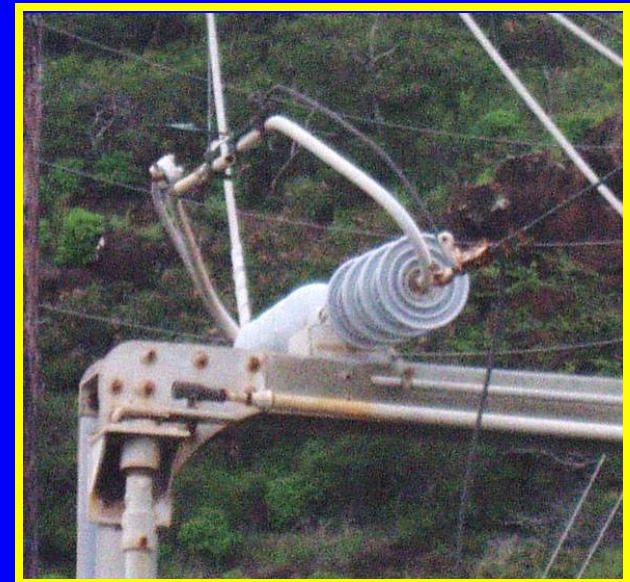
Closed Switch 46kV

- A “closed” circuit is where the power is flowing through the circuit without interruption.

When a circuit is closed,
electrical power can flow

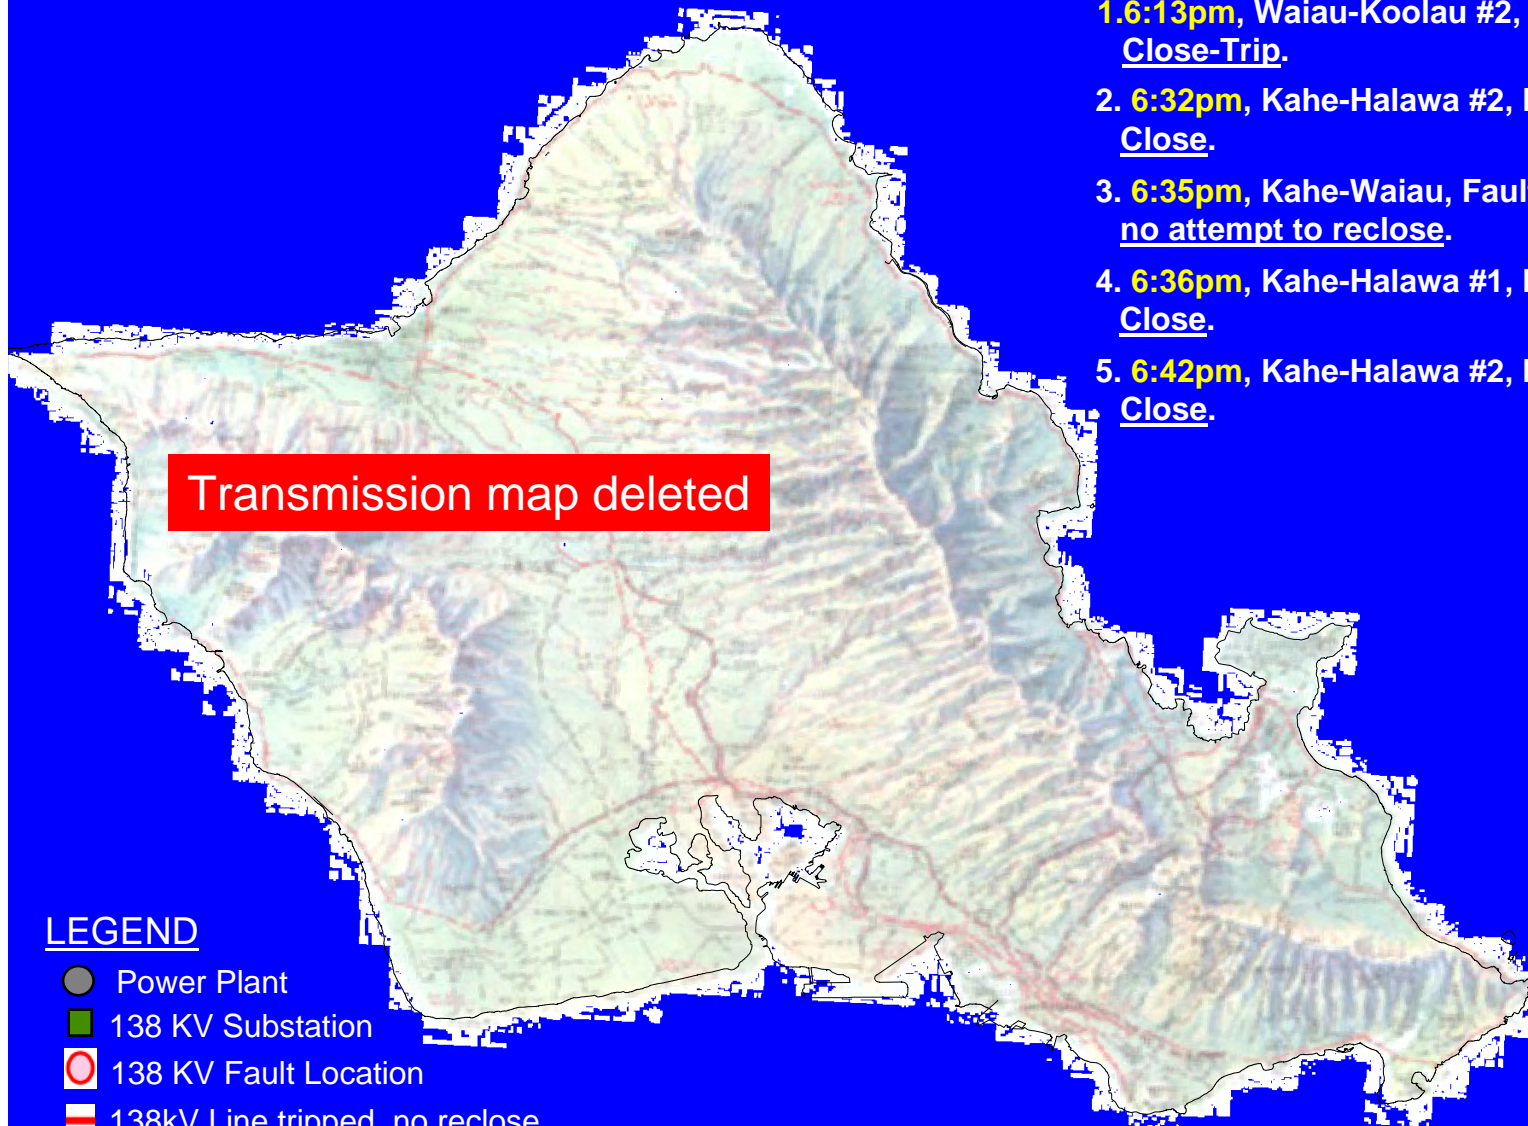
138kV Transmission Line Fault Locations

1. **6:13pm**, Waiiau-Koolau #2, Fault type: C-Gnd, Trip-Close-Trip.
2. **6:32pm**, Kahe-Halawa #2, Fault type: A-Gnd, Trip-Close.
3. **6:35pm**, Kahe-Waiiau, Fault type: A-B-C, Trip-no attempt to reclose.
4. **6:36pm**, Kahe-Halawa #1, Fault type: C-Gnd, Trip-Close.
5. **6:42pm**, Kahe-Halawa #2, Fault type: A-Gnd, Trip-Close.

Inspections to date have eliminated Nos. 1, 2, and 3...and evidence of what appears to be a lightning strike has been found on the Kahe-Waiiau line

Transmission Line	HECO Relay Date & Times	PacNet Detects Lightning Strikes Date & Times
Kahe-Waiiau	12/26/08 - 18:35:30 HST	12/26/08 - 18:35:30 HST
Kahe Halawa #1	12/26/08 - 18:36:22 HST	12/26/08 - 18:36:22 HST

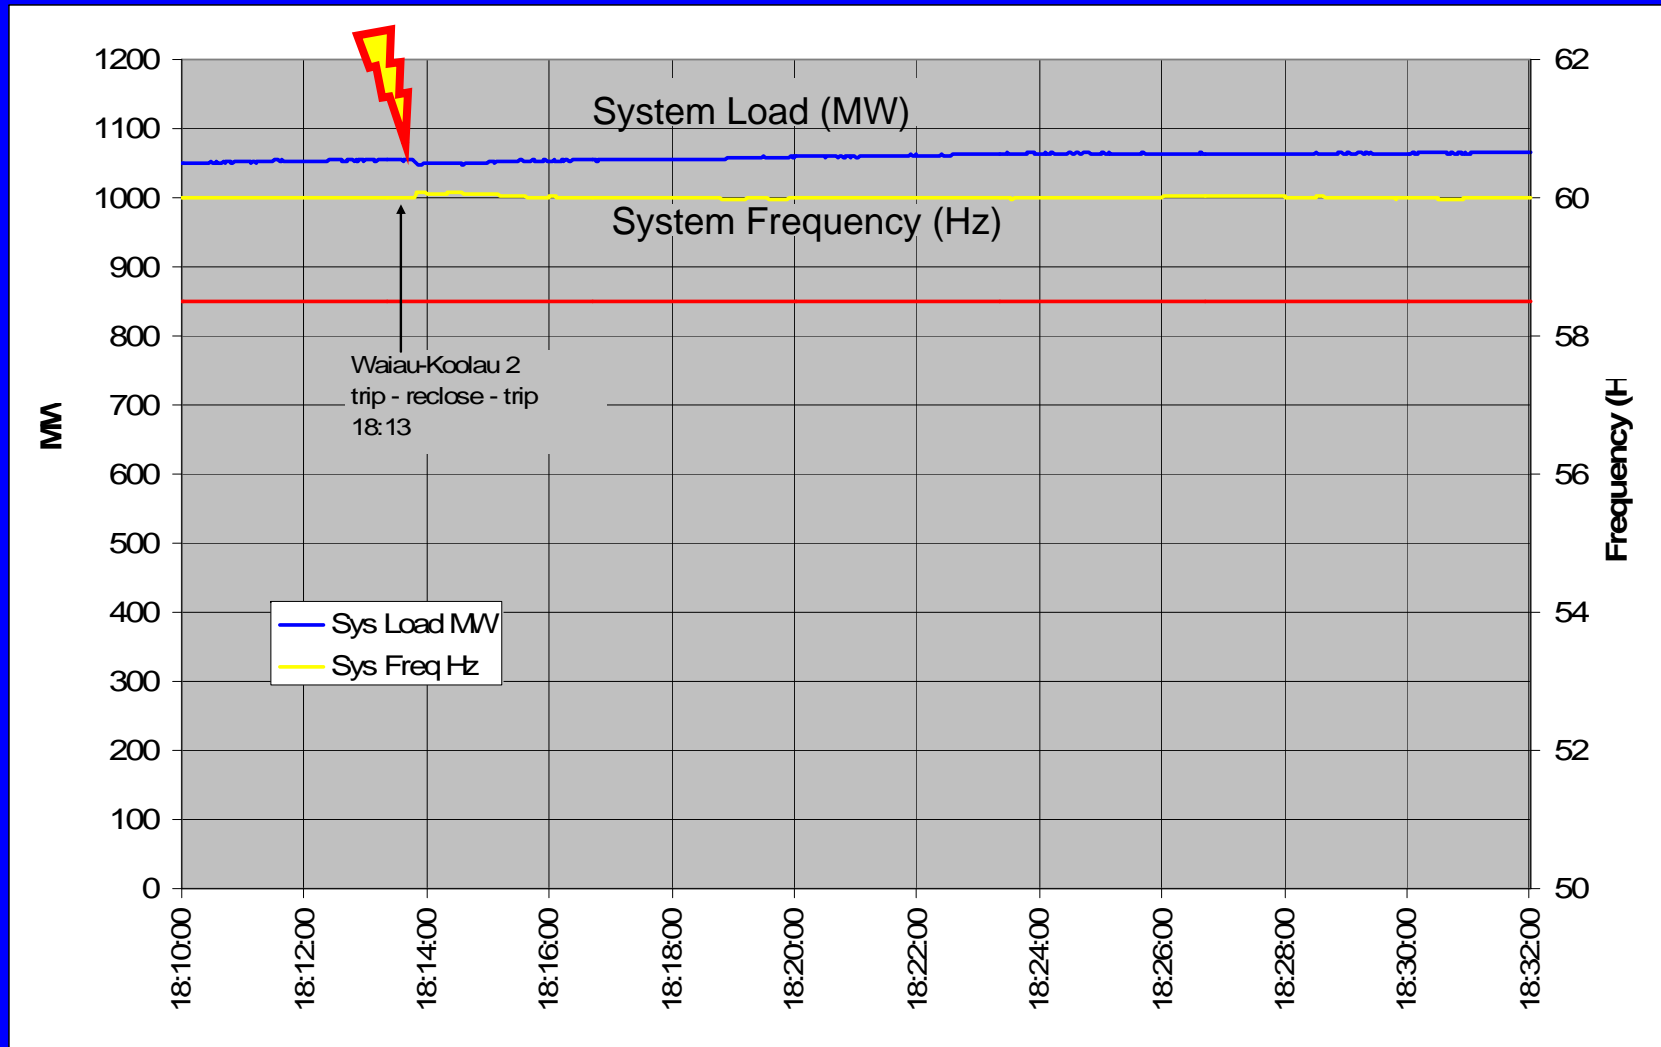
System Generation & Freq. vs. Time

Friday, December 26, 2008, 18:10-18:32

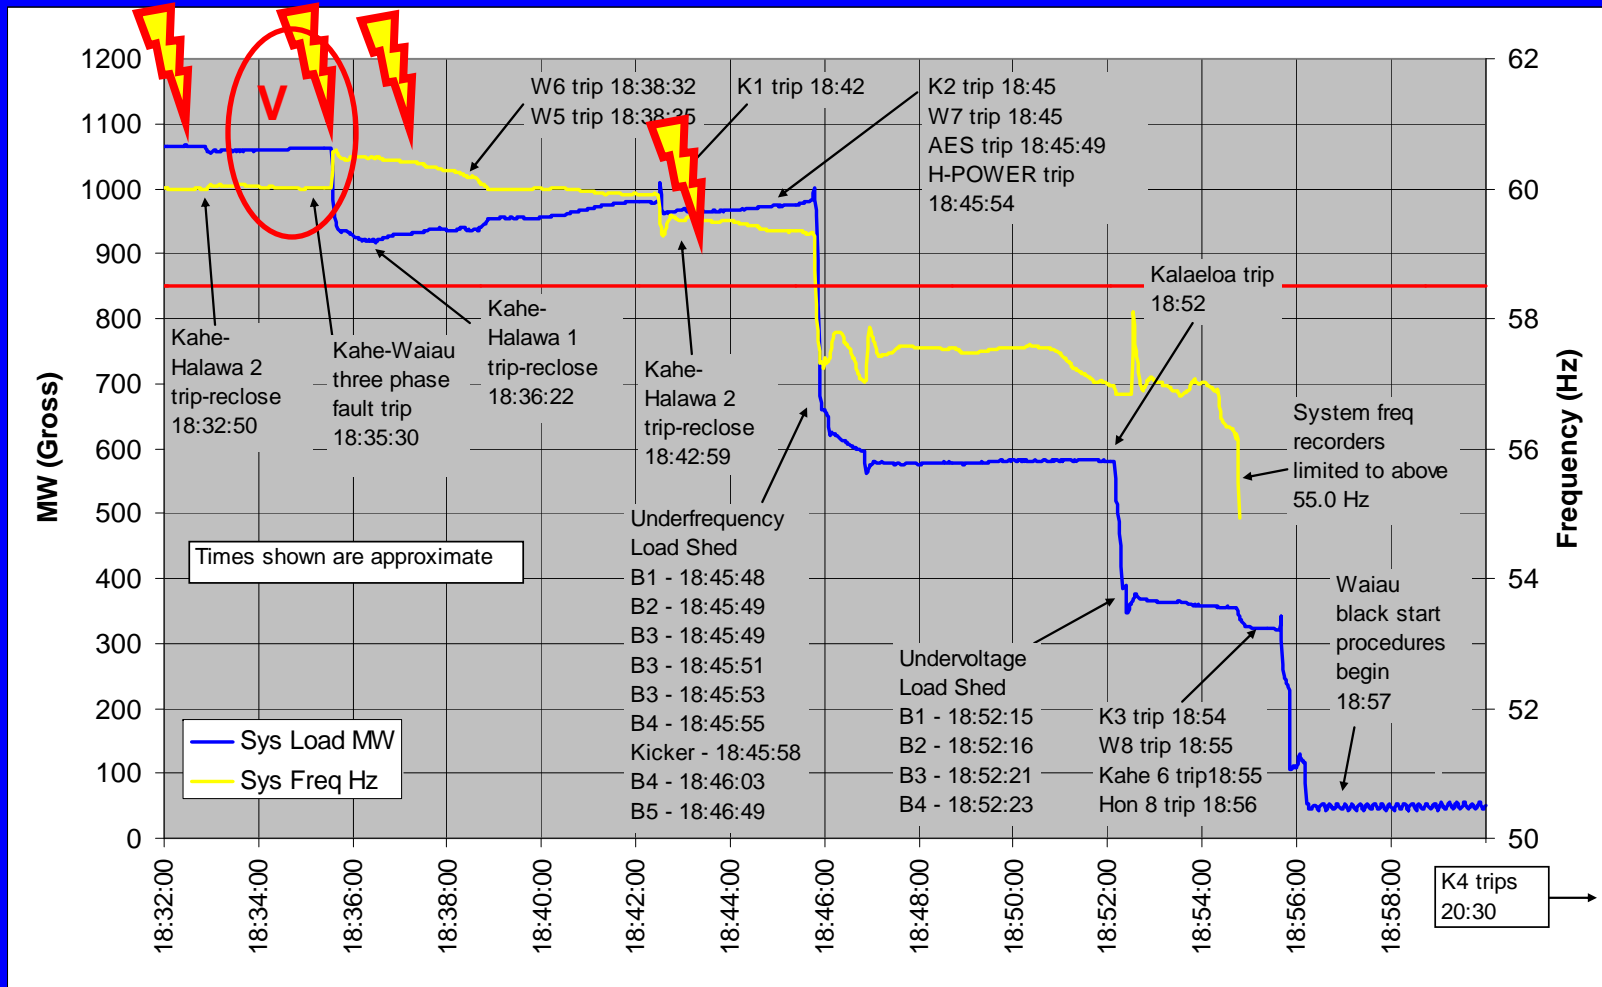
System Generation & Freq. vs. Time

Friday, December 26, 2008, 18:32-19:00

- Severe and unusual lightning strikes caused multiple short circuits on the transmission system, resulting in increasing system instability
- This instability caused a significant amount of customer load to shut down followed by a series of generation shut downs and the eventual island-wide outage

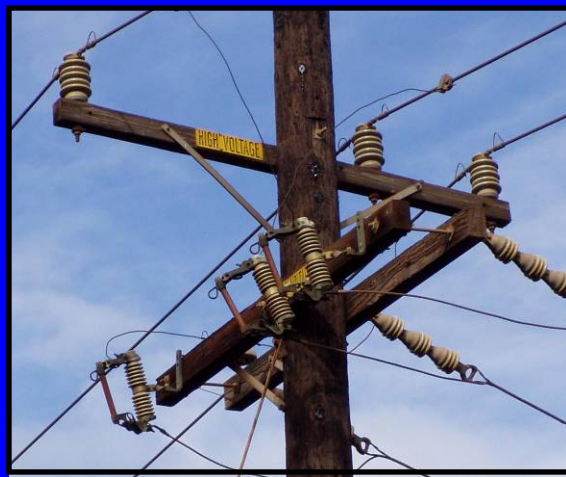
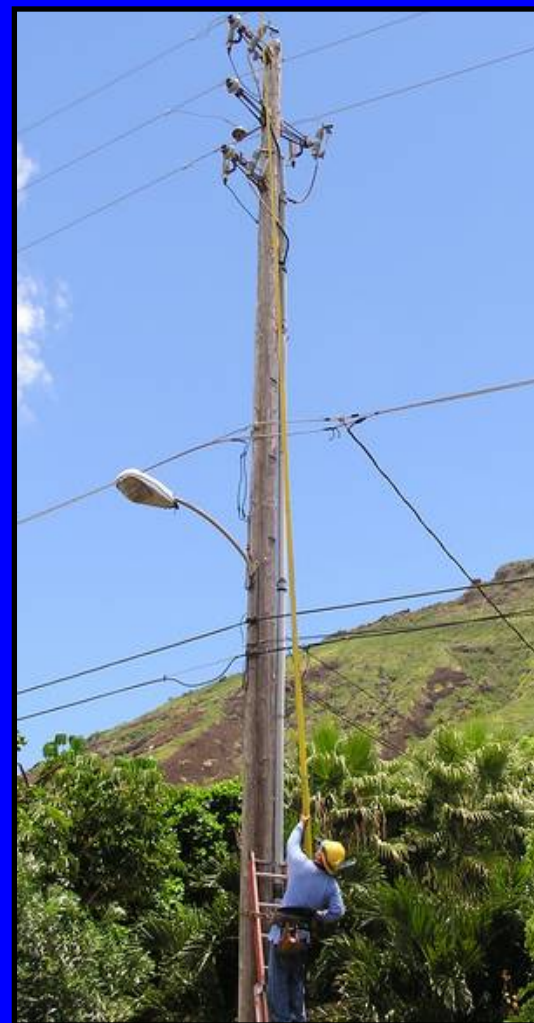
Pocket Outages

- By 3:00pm on December 27th, all distribution circuits were energized
- Crews worked until the early morning of December 28th, to restore customers affected by pocket outages
