**In consideration of  
SENATE CONCURRENT RESOLUTION 45  
AUTHORIZING THE ISSUANCE OF A TERM, NON-EXCLUSIVE EASEMENT  
COVERING A PORTION OF STATE SUBMERGED LANDS AT PUAMANA,  
LAHAINA, MAUI FOR VARIOUS SEAWALL STRUCTURES. A CONCRETE GROIN,  
AND REVETMENT FOOTINGS OF A HISTORIC SWIMMING POOL**

**TESTIMONY IN SUPPORT OF SCR 45**

Re: Structural Engineering Review Update  
Puamana Pool  
Puamana, Maui, Hawaii

## SOUTH FACE OF POOL WALL & FOUNDATION 2008 VS 2015

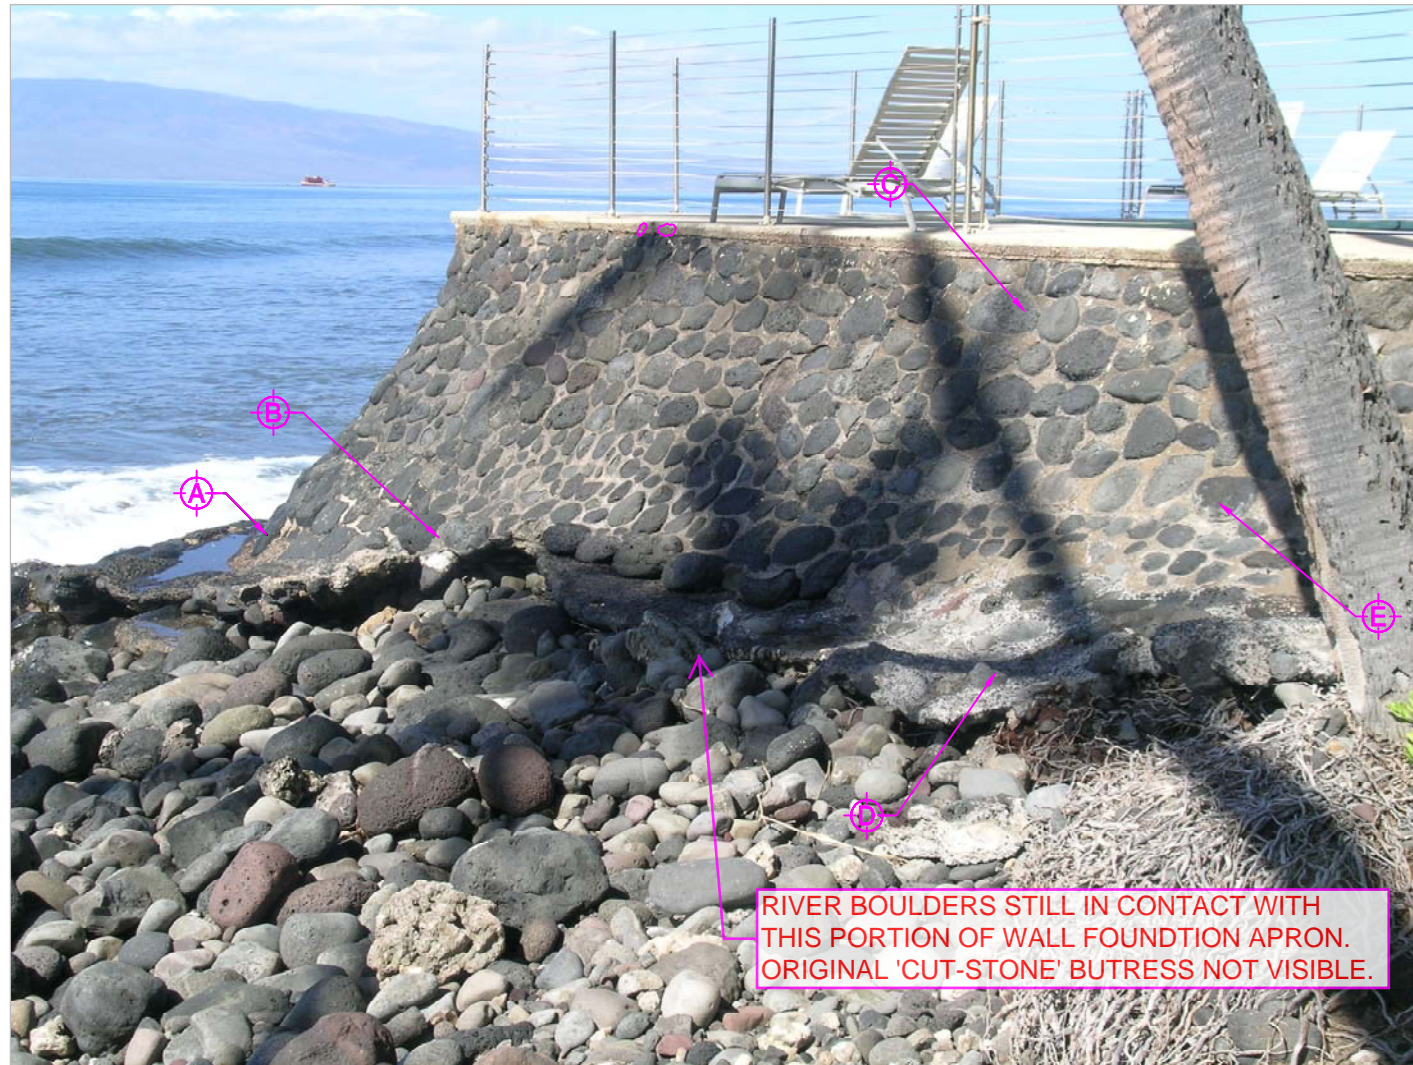
**POOL WALL & FOUNDATION ALONG  
KA'AULA STREAM (2008)**

Observations made during our recent visit provide evidence that the undermining of the pool retaining structure's foundations has advanced significantly since last observed in 2010. This is especially true along the south-facing side of the pool adjacent to the mouth of Kau'aula Stream where river boulders have been the primary elements supporting the base of the pool walls. The level of the boulders beneath the wall foundation skirt has dropped appreciably since 2008 and 2010, to the point where the mortar and stone foundation apron is breaking away more extensively. Where the boulder level in 2008 was approximately level with the bottom of the foundation apron, it has now dropped well below it, with caverns opening up under the wall that

ⓐ WHERE SHOWN THIS DESIGNATES MATCHING POINTS OF ROCK ALONG FACE OF POOL WALL

Based on the advancement of the erosion along the south side of the pool, we now feel it to be imperative that the foundation repair/reinforcement process commenced as soon as possible before damage occurs that might make the continued use of the pool impossible. Further delays of a year or more could produce this result. The rate of deterioration since our 2008/2010 observations is quite significant, with the extent of foundation undermining becoming critical.

In 2012 our office prepared preliminary drawings for execution of the foundation reinforcement utilizing a process of injecting urethane foam into the soil/sand/rock material directly beneath the pool and its walls. The material recommended has been used successfully in seawall reinforcement efforts in Hawaii, Florida and other coastal locations in the U.S. that are subject to erosion and shoreline recession. The injected foam material can be used to solidify soil/rock material beneath the wall foundations to a depth of 2-3 feet, resulting in the material being made much more resistant to erosion. The foam essentially cements the rock/soil materials into a solid mass to the depth to which it can be injected.

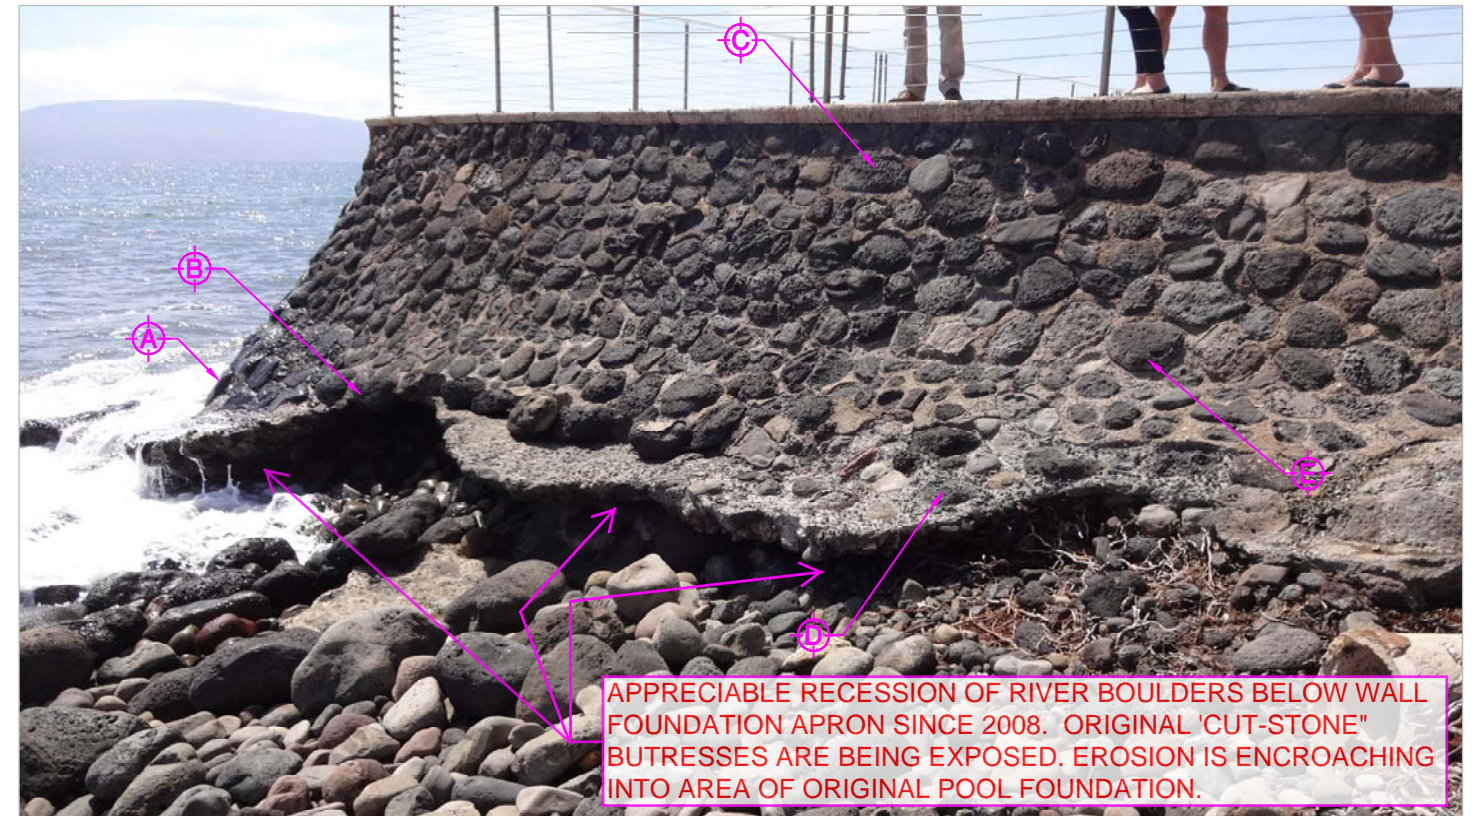
**POOL WALL & FOUNDATION ALONG  
KA'AULA STREAM (2015)**

were previously not present. Wave energy is now able to directly attack the cut-stone retaining wall buttress elements (similar to Wailuku Bridge stones) of the original 1935 pool construction. The caverns have formed along about 75% of the south pool wall extending down and around the Makai corner. The average level of the boulder array is now approximately 12-18" lower (more in some locations) than it was, and the bases of the original cut-stone buttress are visible where previously they were not. Recent occurrence of high wind events (Flossie in 2013, Iselle, Julio and Ana in 2014) have likely contributed to the observed boulder recession. Images of the south pool wall in 2008 and 2015, included herein, depict the advancement of the erosion beneath the wall foundation apron. Although the shot angles are not identical, match points provided (specific stones in the wall) can be used as points of reference.

**COMPARATIVE VIEWS**  
**SOUTH FACE OF POOL WALL**
