**THE THIRTIETH LEGISLATURE
APPLICATION FOR GRANTS
CHAPTER 42F, HAWAII REVISED STATUTES**

HALE PUNA

Hale Puna is requesting funding to conduct emergency repairs on a historic property in Waimea Town, Kauai, and launch a \$2 million capital campaign to restore this 190 year-old site representing a vital part of Kauai's history.

HISTORIC STRUCTURES REPORT
FOR
THE GULICK-ROWELL HOUSE
Waimea, Kauai, Hawaii

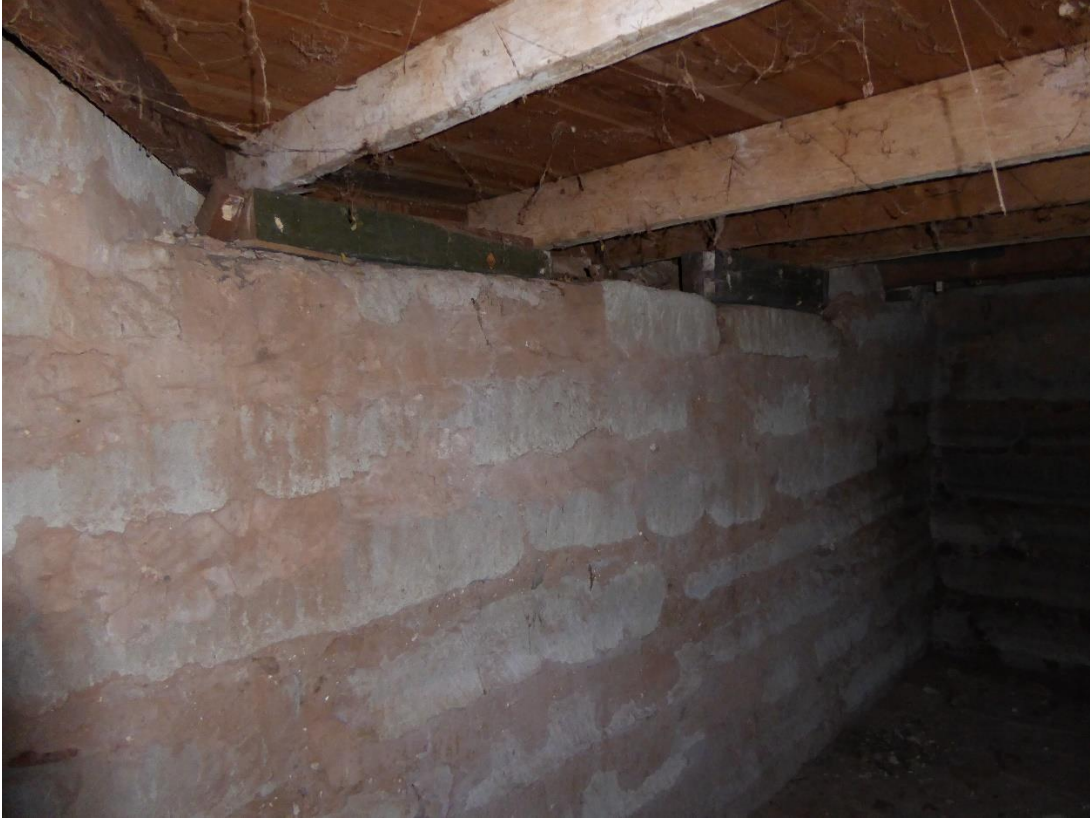
Despite Gulick's mention of being able to get lime "as fast as it will be wanted" it should be noted that the cellar walls were mortared with what appears to be a modified adobe. Lime may have been used as a binder, but the primary material in the mortar is soil (Figure 4). The walls above the cellar level are mortared with lime-based mortar.

Figure 4: Portion of cellar wall

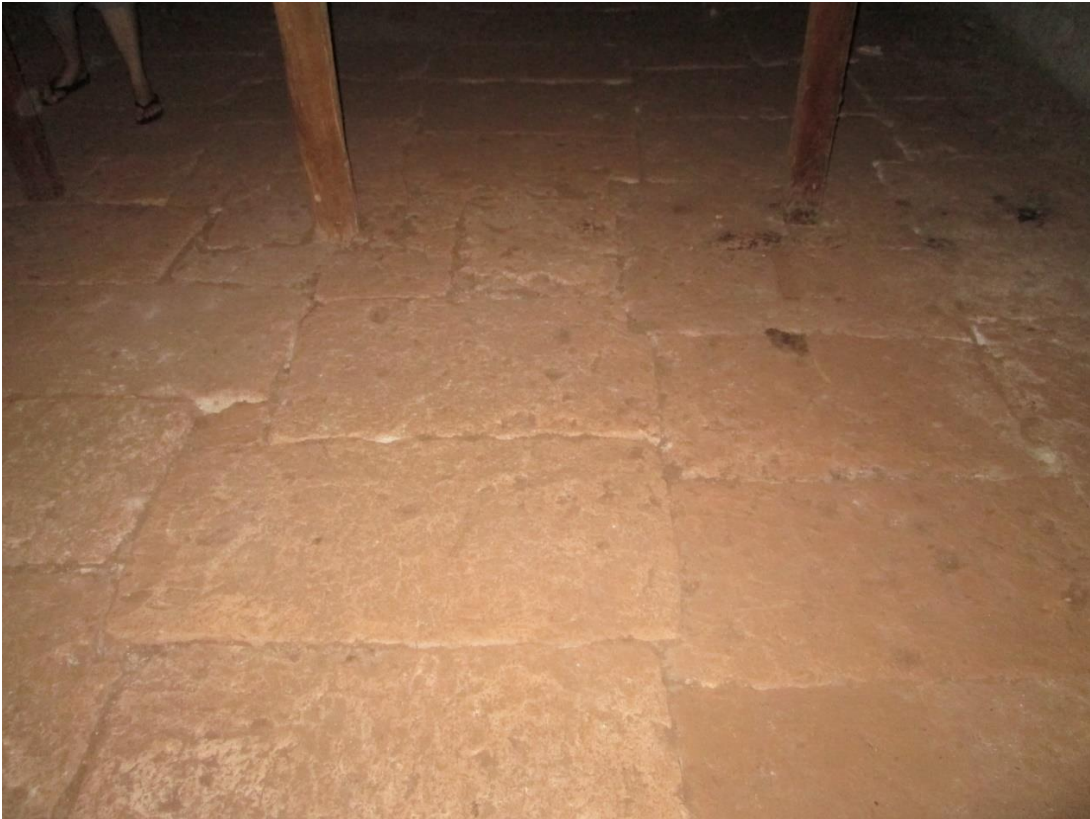
The cellar floor is paved in large sandstone blocks, some of which are notched around other stones (Figure 5). This is an unusual floor and it is doubtful there is another building in Hawaii with such paving.

Figure 5: Example of cellar paving

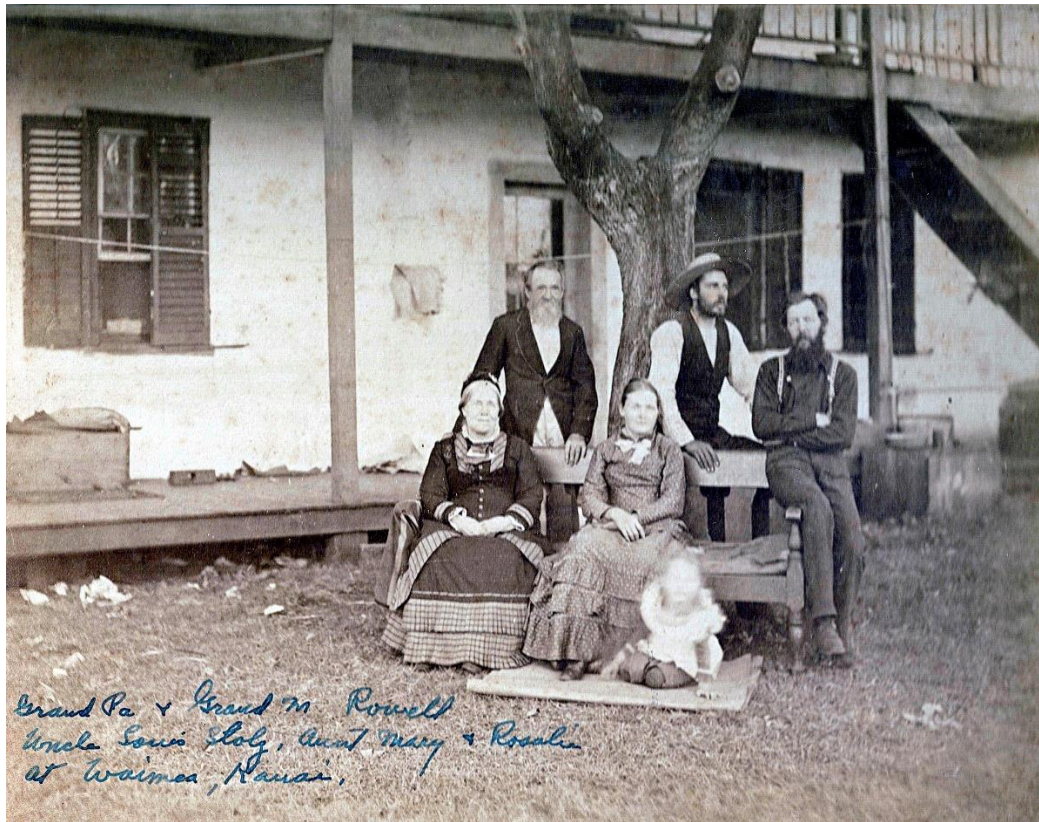
In 1927 various changes were made to the building. The most significant of those is the exterior decks. The original decks were wood framed at both first and second floors (Figure 6). They also appeared to be narrower, at least on the sides. The Rowell-era deck terminated in a single-story addition on the first floor, east side (Figure 1) and had a stair that lead to the second floor deck on the same side, which was as wide as the deck. The railing design of the original was simpler and the posts were slightly outset of the perimeter beam, instead of being visually interrupted by the beam, as in the case today. The most significant difference is the fact that the current first floor of deck is smooth cast in place concrete.

Figure 6: Original decks were wood framed.

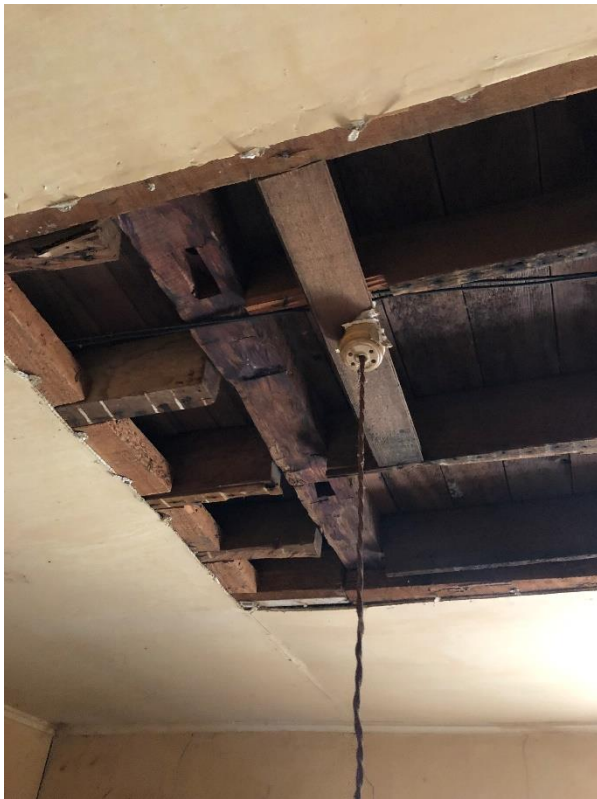
Figure 7: Ceiling in bathroom is 14" thick gypsum board attached to original hand-hewn framing.

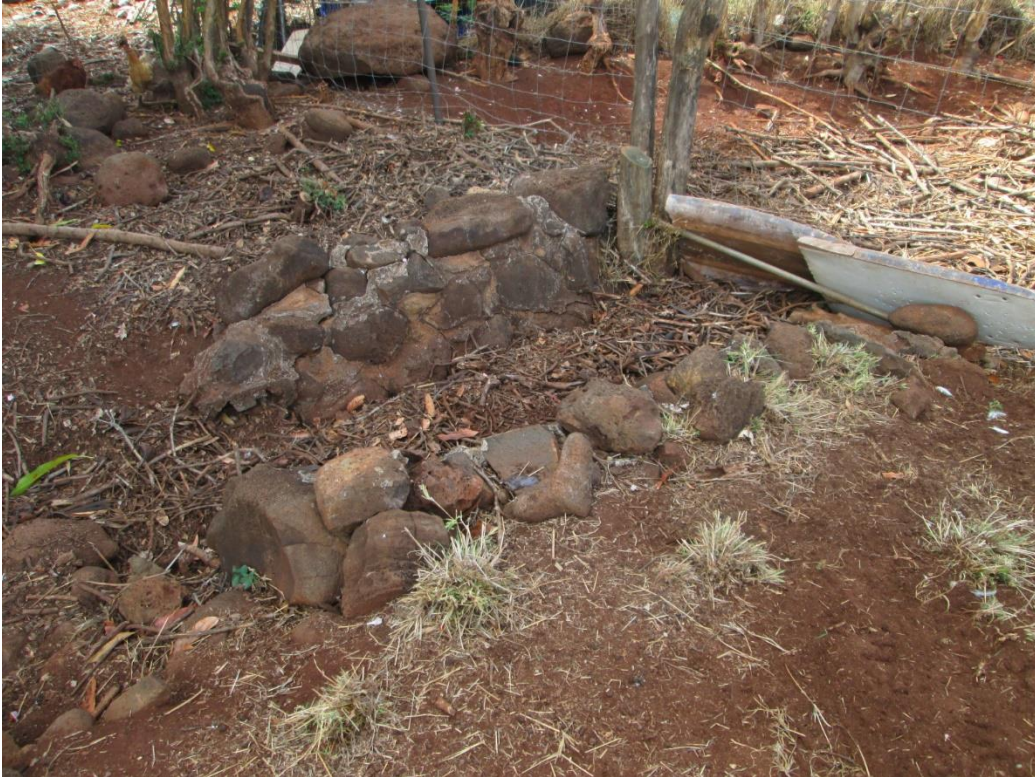
Other historic elements include the concrete slab of a former carport that was attached to a board and batten building to the north of the house. All that remains of that portion of the building are rubble stones that marked the perimeter of the structure (Figure 10).

Figure 10: Remains of the foundation of the former structure at north part of the site.

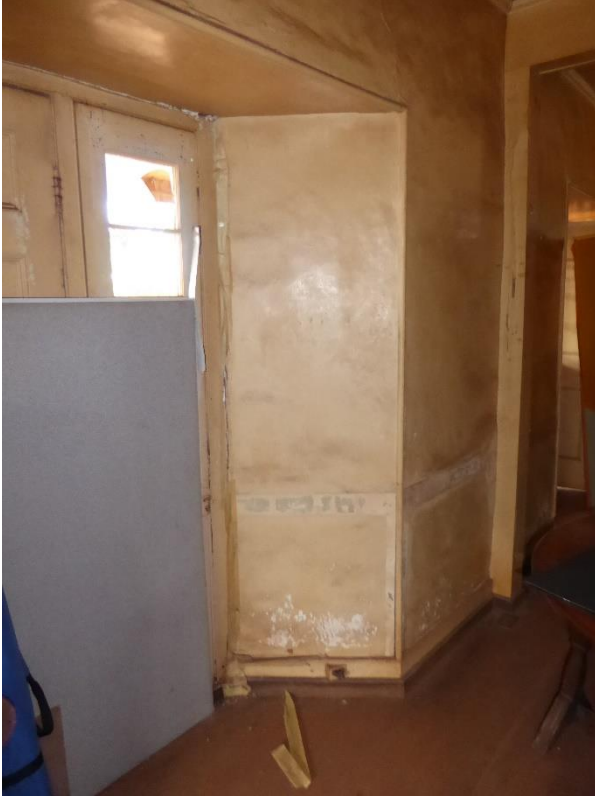
Interior walls of the first and second floor are wood studs with plaster on wood lath. The plaster is applied over masonry at the exterior walls and except in one case over lath and plaster on wood studs for interior walls. That exception is the wall between the Parlor and the Sewing Room. This is a plastered masonry wall, which may at one time been an exterior wall. At the east side of the Parlor most of the walls have a wood wainscot. The wood trims that define this wainscot have been removed adjacent to where the wall was removed (Figure 16). The west side of the Parlor shows no sign of ever having a wainscot.

Figure 16: Shadow of former wainscot trip is evident on this portion of the east section of the Parlor.

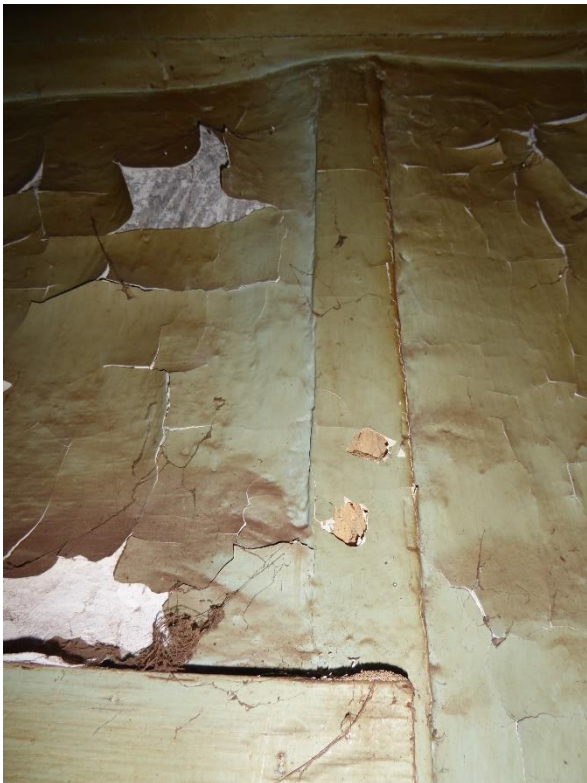
The one exception to the more normal interior plaster wall construction occurs at the wall between the Kitchen and the Dining Room. This wall is supported by 2" by 3" verticals at about 28 inches on center. On the hall side the wall appears flat with the plaster finish skimmed over the face of the verticals (not more than about 1/8" thick). On the kitchen side the verticals are exposed and the plastered surface has a slightly concave shape between each vertical (Figure 17). At its thinnest the wall may be no more than 1 1/2" thick. It is assumed this wall was made by plastering over wood lath only, between the verticals but this cannot be verified until the wall is partially dismantled, which will be necessary to replace two of the verticals that are entirely termite eaten.

Figure 17: Original stud shows on interior of Kitchen, with shallow scalloped plaster wall between studs.

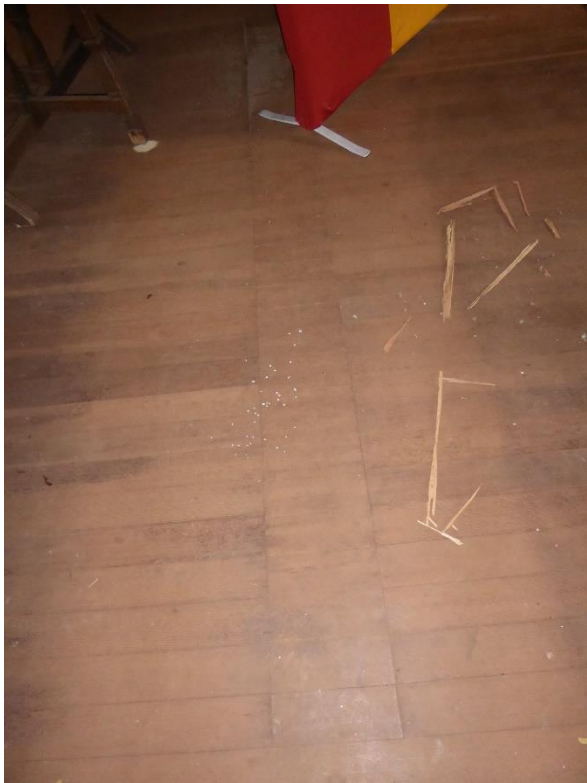
Figure 21: Patch in the floor of the Parlor where the wall was removed.

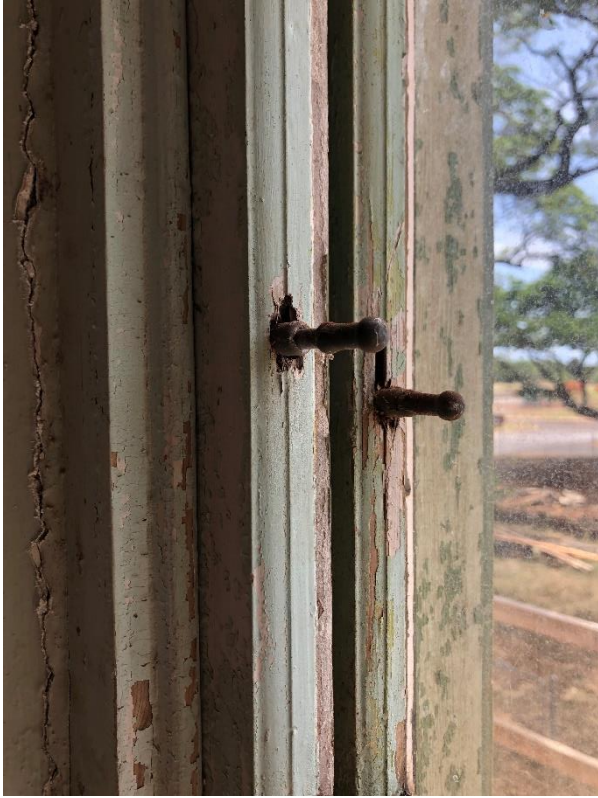
Figure 26: Window 28 is the only window with this type of spring sash holder.

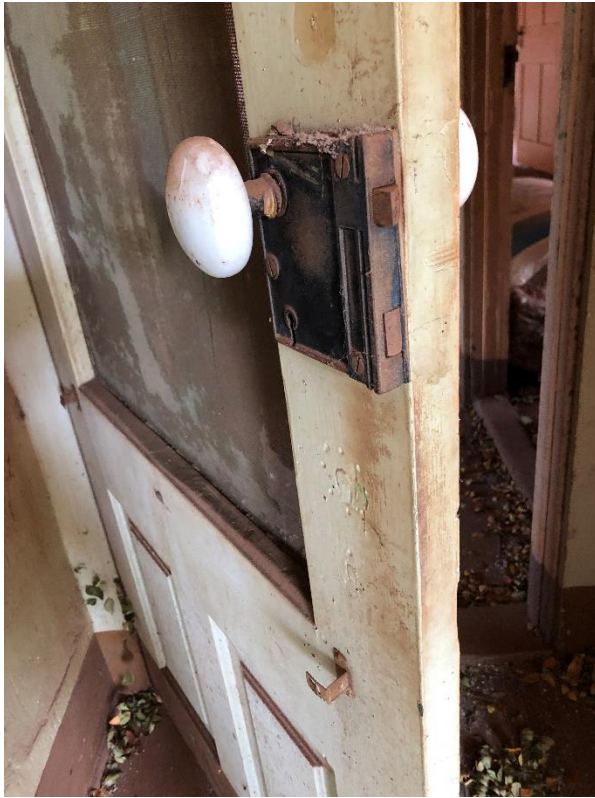
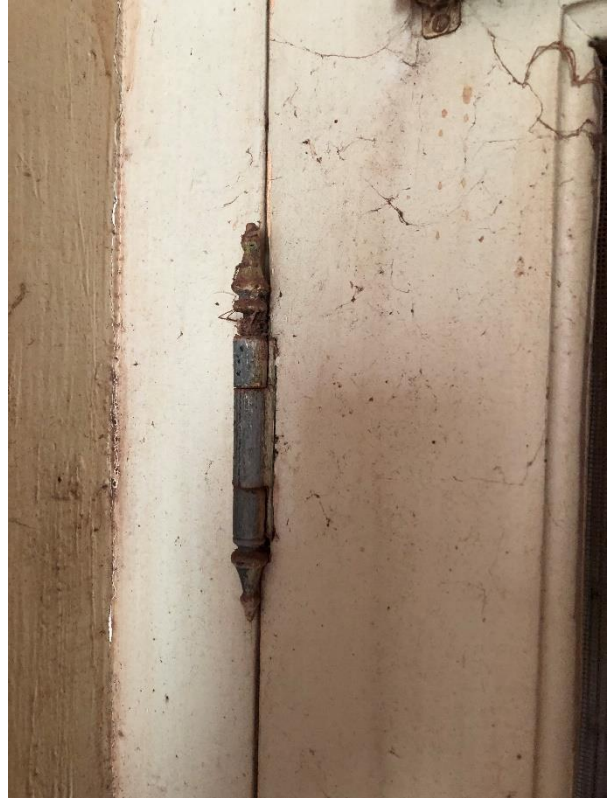
Figure 37: Door R lockset on the left and hinge style on the right.

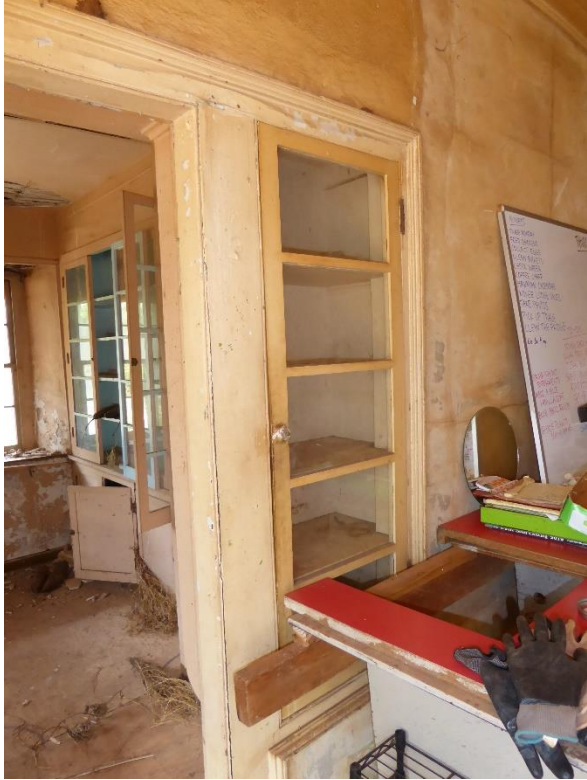
Figure 42: One of the two cabinets in the Dining Room flanking Door G. This cabinet has a door. The other cabinet is missing its door.

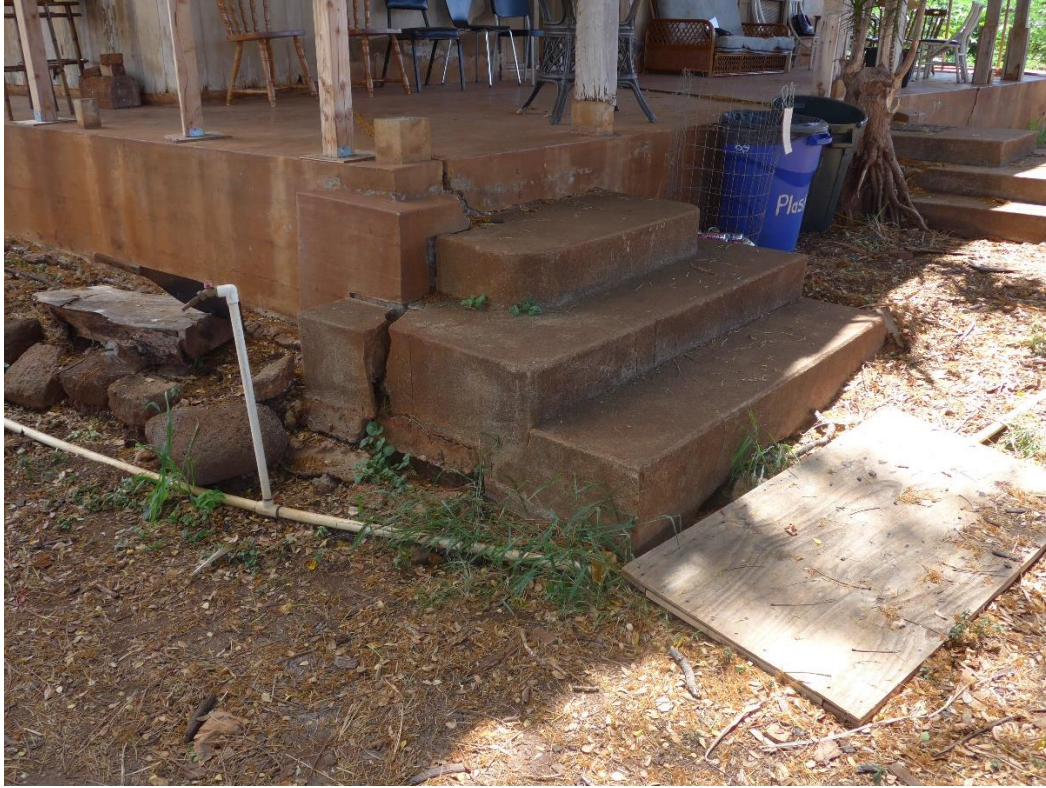
Figure 46: Stair at southwest corner

There are three exterior stairs. Two are plastered masonry and both are on the south side and lead to the south deck (Figures 46 and 47). Based on the cracking pattern it is likely these are made of stone blocks that have been smooth plastered.

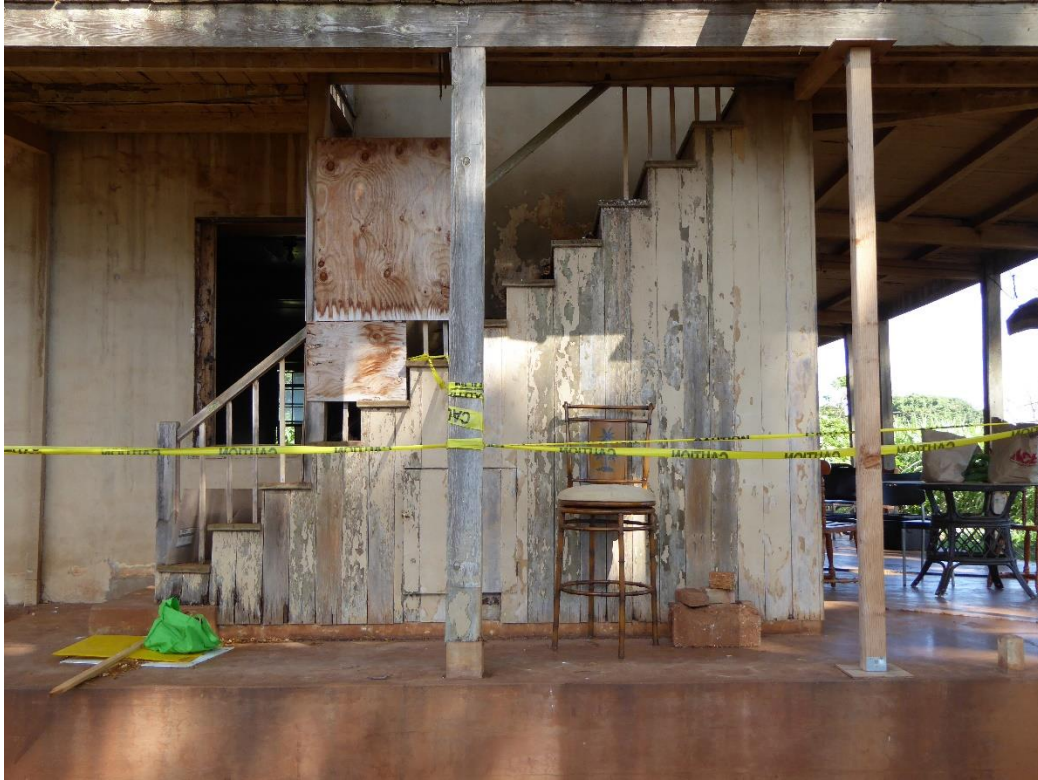
A wood framed stair at the south end of the west deck leads to the second floor deck. The bottom riser is concrete, which would indicate that this stair was constructed in 1927. The underside is enclosed with 1 x 6 tongue and groove boards with sand finish paint on the exterior. The enclosed space was used for storage. This stair is in poor condition and will need to be reconstructed since the stringers are termite eaten (Figure 48).

Figure 48: Exterior wood stair. Photo taken in 2015.

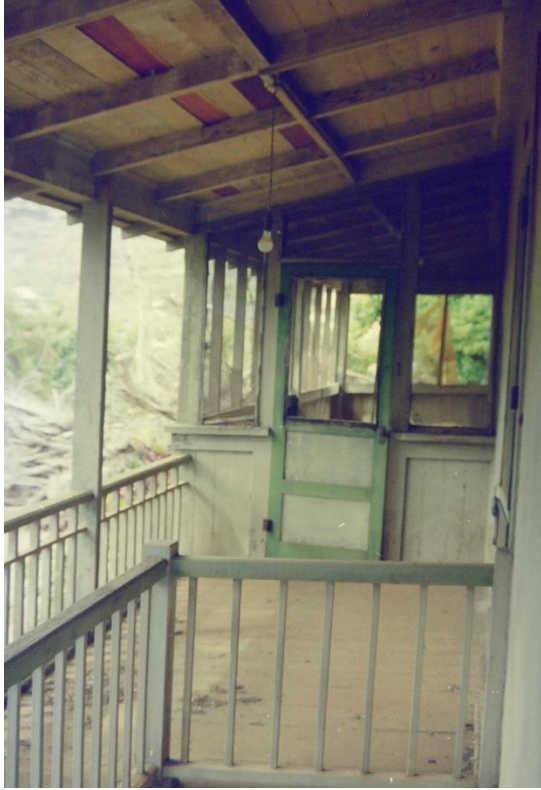
There was a screened portion of the upper deck at the north end of the west side. This is no longer extant (Figure 52).

Figure 52: Former screened portion of west upper deck.

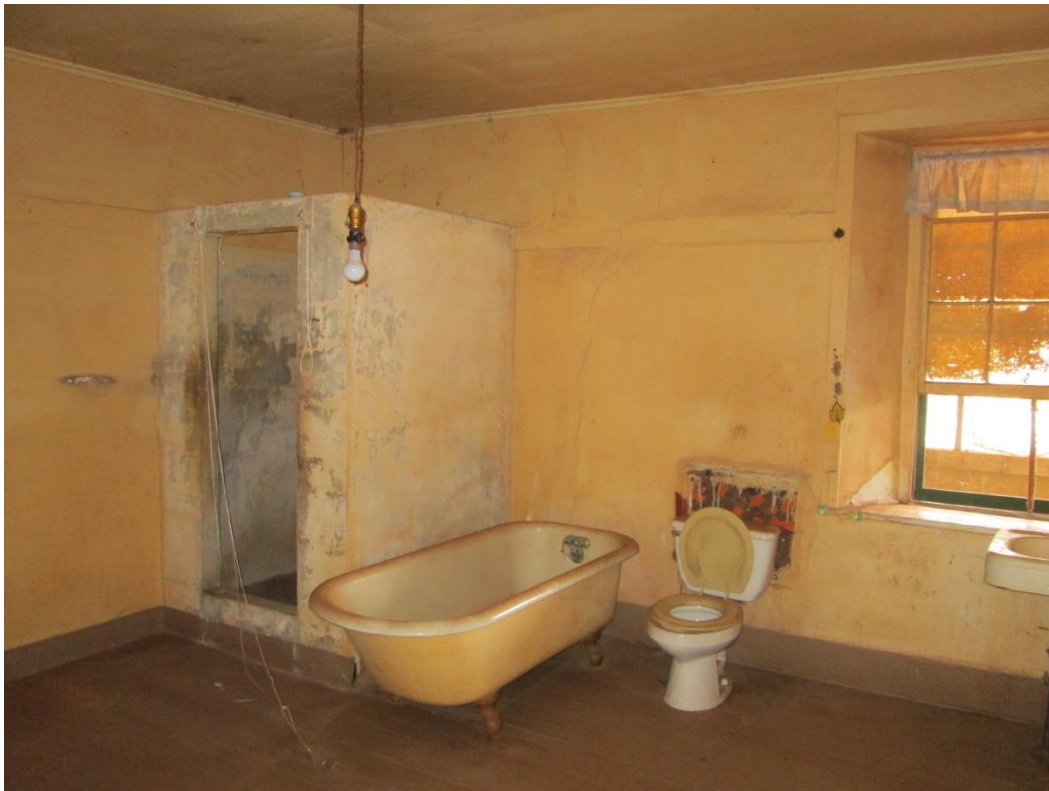
The bathroom has a sheetmetal-lined shower, freestanding tub, toilet and wall-mounted sink (Figures 53 and 54). The toilet appears to be of a more modern design but the other elements could be from the 1927 renovation.

Figure 53: Bathroom showing toilet, tub, and shower. Part of sink is shown on the right.

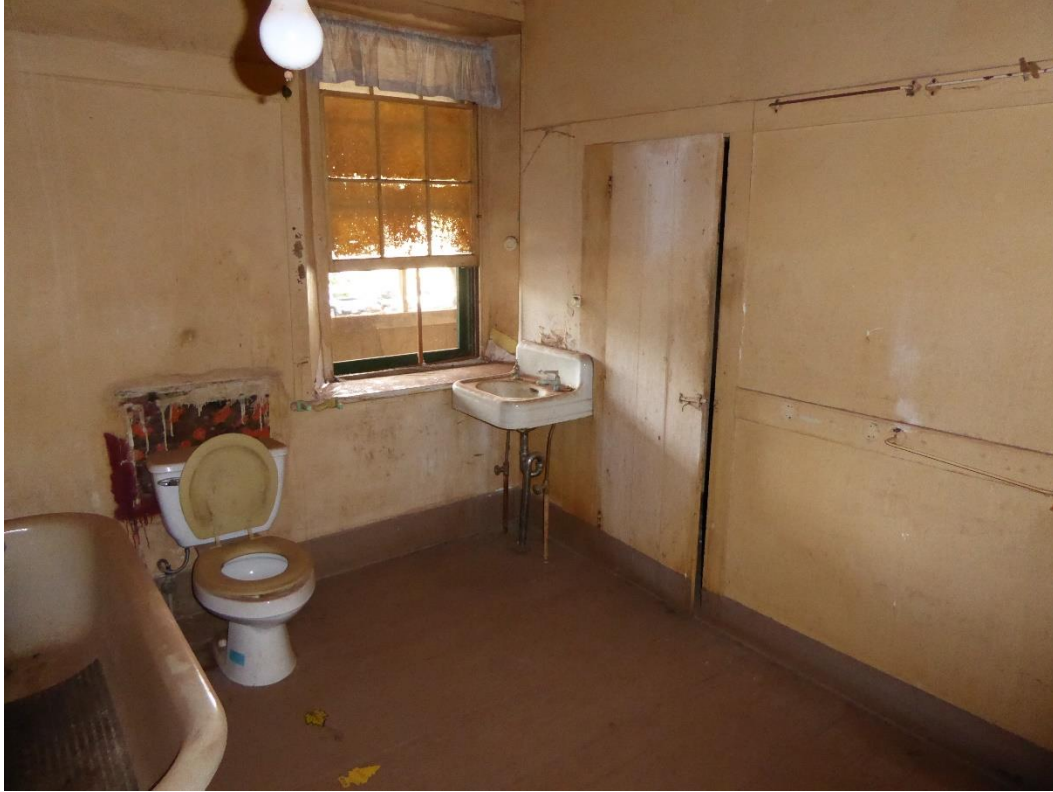
Figure 54: Bathroom showing the sink, storage closet door and window.

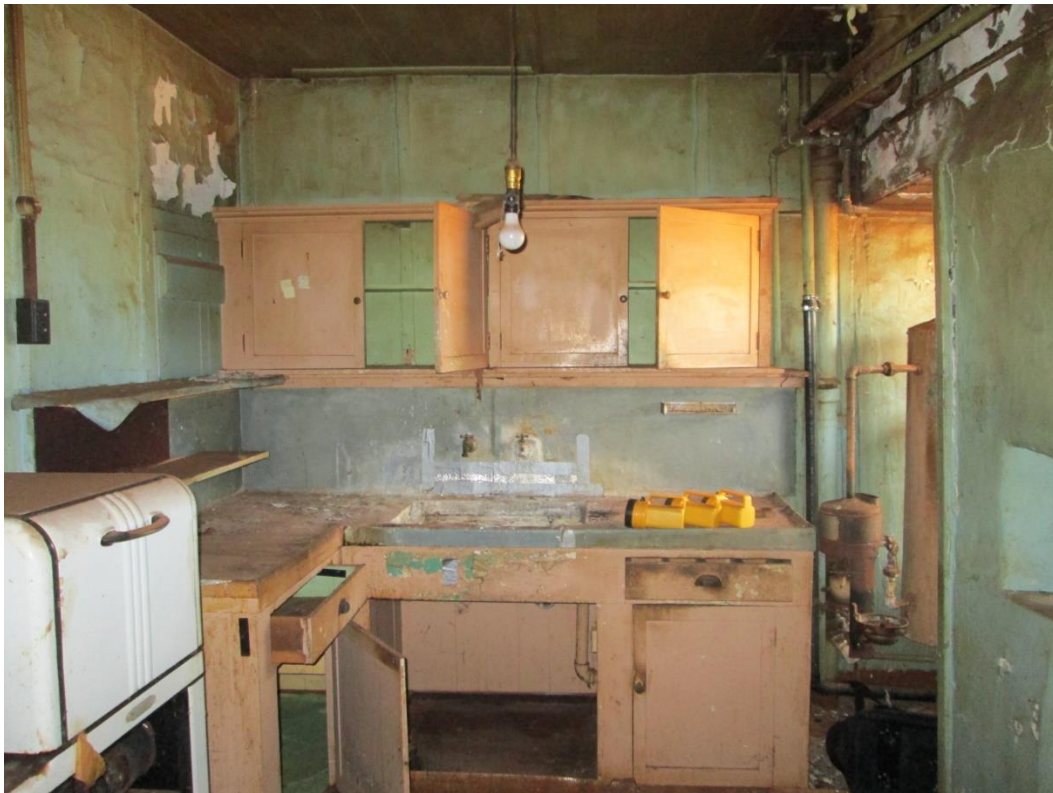
The kitchen has a cabinet with a sheetmetal countertop and sink (Figure 55) and a range (Figure 56). To the right of the sink cabinet is what appears to be a small water heater. The dates of these elements is not known but they are not of recent vintage.

Figure 55: Kitchen sink and cabinet.
