Hilo Child Development Center (Head Start Program)

Grant-In-Aid CIP Application for Grants & Subsidies Fiscal Year 2015

SCOPE OF WORK PACKAGE FOR:

STRUCTURAL ASSESSMENT FOR:
THE Child Development Center
2133 Waianuenue, Hilo, Hawaii

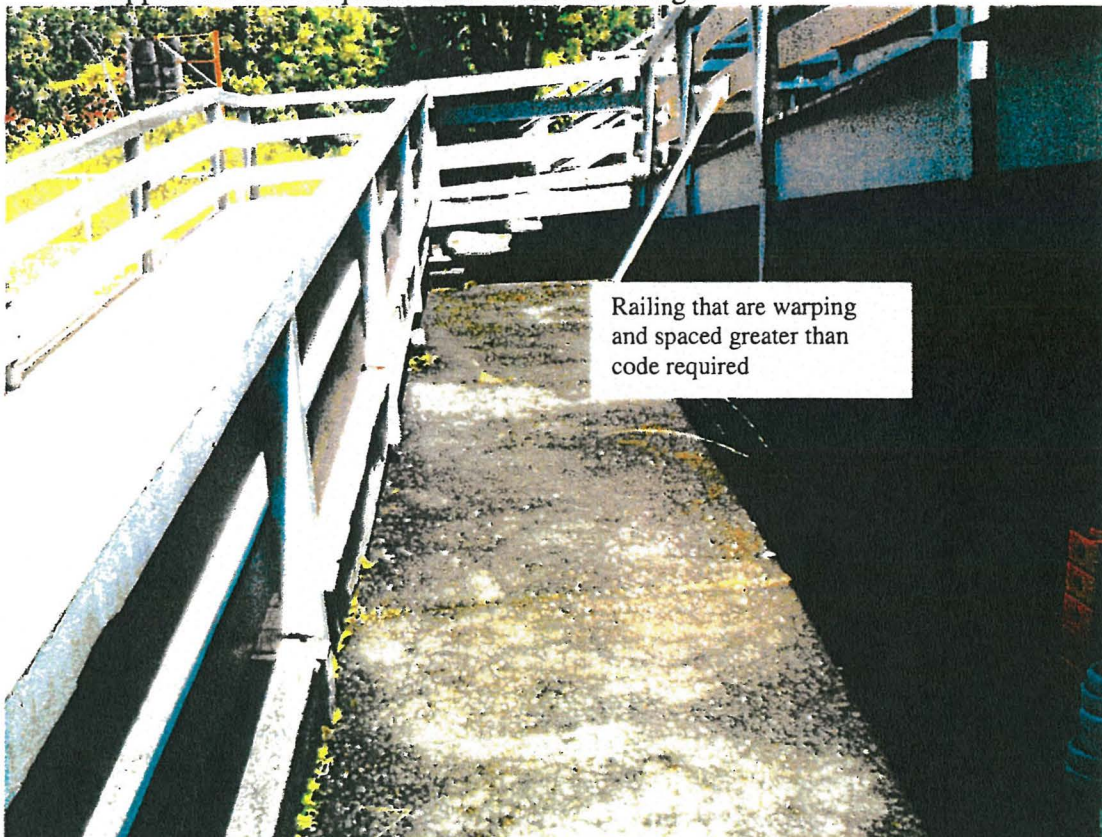
Figure 1 - West Ramp looking North

- 1.1 Currently the area of the greatest concern is the railings around the building. Code requires that a sphere 4" or greater cannot pass through any of the railings. The railings are wider than this gap, which means that a child could get his head stuck in the railings. The railings to the ramp are also warped and built out of a manufactured lumber that is not suitable for railing applications and will not support the code required lateral load for railings.

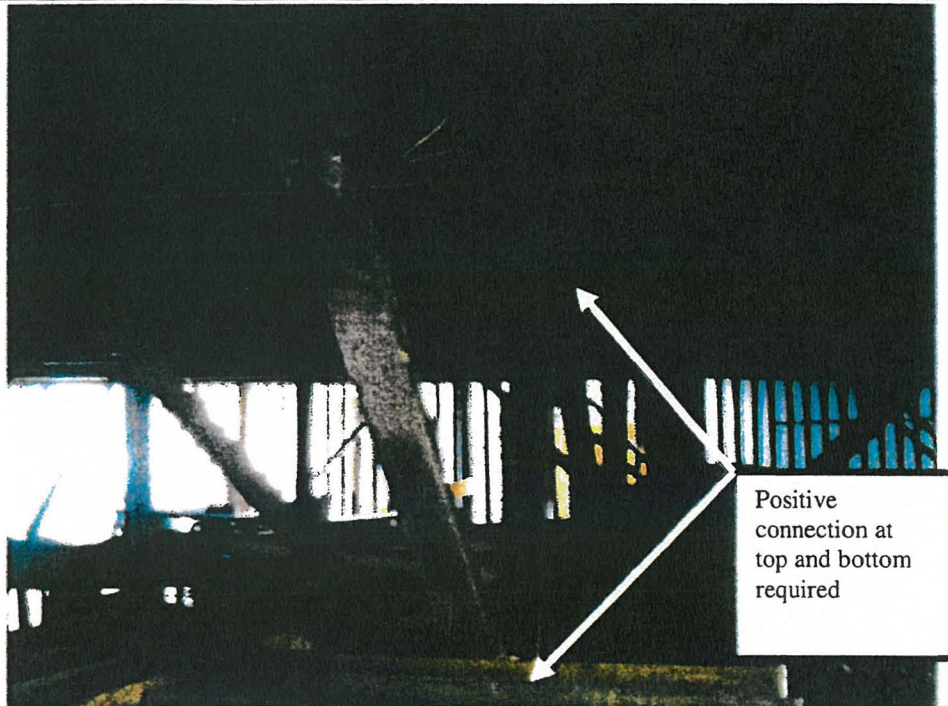
Figure 2 - Photo of bottom area of North Building

- 2.4 The 4x6 beams holding the first floor joists are supported by existing 4x4 columns. These columns will need to be attached to the beams with flat a LTP4 or APC44. This will create a positive connection between the post and the beam. If the column is set on existing concrete there will need to be an A311 angle attached to the concrete with a 1/2" threaded rod epoxied 3" into the concrete. The A311 will need to be lag bolted to the post with a 1/2" lag bolt embedded 3" into the wood. If the 4x4 is set on lava rock, a new pre-cast concrete pad 16" square with an embedded base will need to be set on compacted soil fill under these posts.

- 6.5 Attach Simpson LTP4 or APC44's to 4x6 beams under first floor joists and existing 4x4 columns. Install A311 angles to concrete base with a 1/2" threaded rod epoxied 3" deep into concrete. The rod is to be stainless steel or the rods are to be cold galvanized on site after placement to cover any exposed steel. A311 to be lag bolted to posts with 1/2" lag bolt embedded 3" into the wood. Where 4x4 is set on lava rock replace with new pre-cast concrete pad 16" square with base embedded onto compacted soil. Section 2.4 Appendix A.

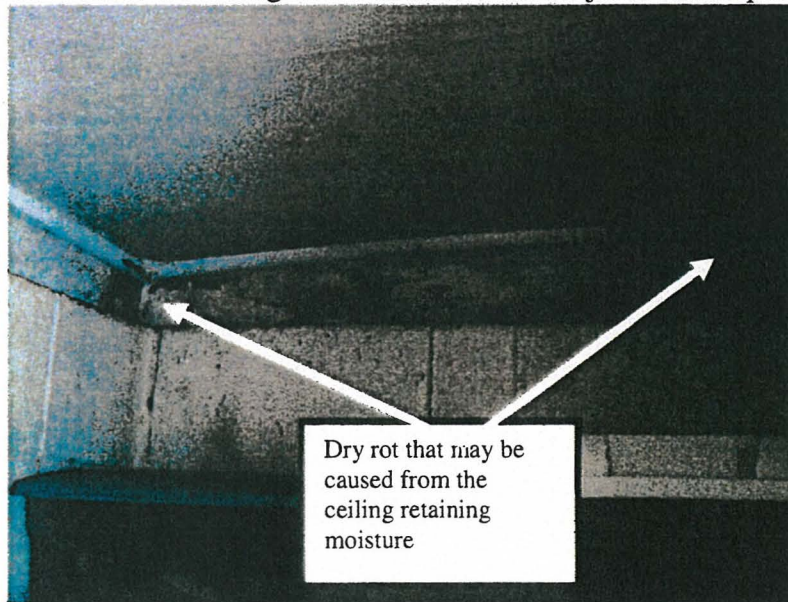
Figure 5 - Ceiling in Toy room

- 2.17 The several of the ceilings on the southern building are currently covered with a gypsum board ceiling. This ceiling is retaining some of the moisture in the floor space and may be causing some dry rot or nesting areas in the floor space. It is best to remove this ceiling covering to let the wood breath naturally. If a finished space is desired, the ceiling can be removed and the joists can be painted.

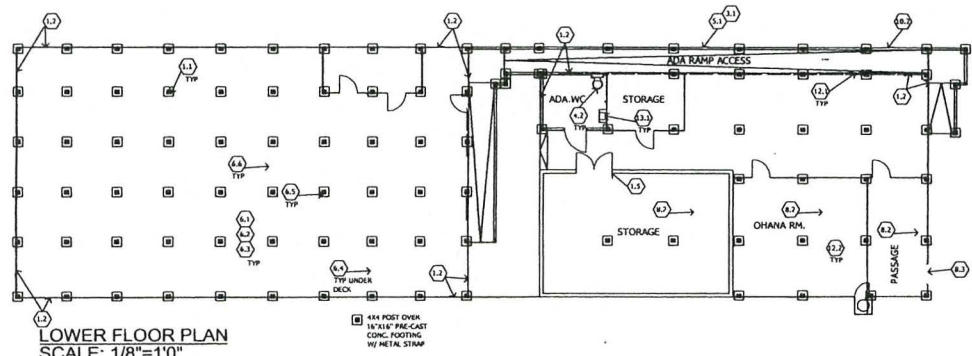
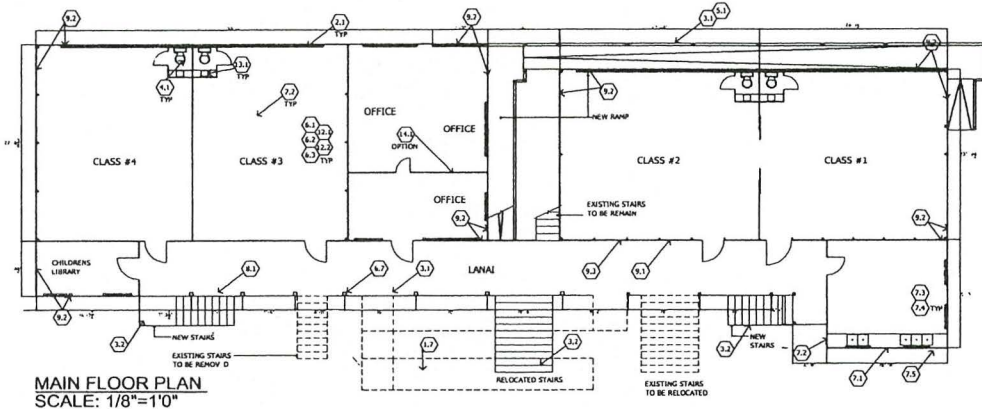
KEYED NOTES ON PLAN
 REFER TO "SCOPE OF WORK PACKAZGE FOR: THE HILO HEADSTART BUILDING"
 THE NUMBER IN THE HEXAGON REFERS TO THE SECTION IN THE ABOVE MENTIONED SCOPE OF WORK
